# **INFORMAL LANDFILL REGISTER - 2025**

*Including Contaminated Land and Flooded Excavations*

## **TONBRIDGE & MALLING BOROUGH**

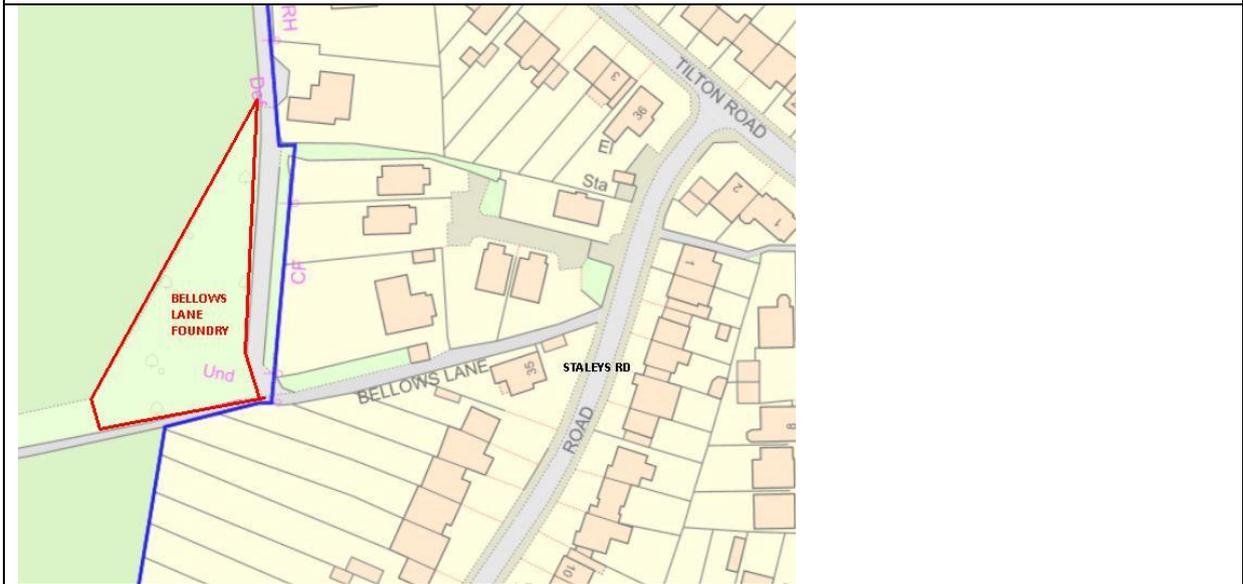
ADDRESS & Co-ordinates	Off Bellows Lane, Staleys Rd Borough Green
Geographical boundaries	<i>Corner of Darkhill Farm field</i>
Operator/s	Possibly Oxley, foundry until early 1900s
Material Excavated	<i>Sand and local ironstone</i>
Excavation Dates	<i>Late 1800s</i>
Landfill Dates	<i>Not landfilled, but cleared and landformed in 2012, safety bund</i>
Landfill Material	<i>Inert soil</i>
Method	
Final Restoration Date	<i>?</i>
Restored to	<i>Left at excavated level</i>
Restored to	<i>wild</i>
Monitoring Regime	<i>None</i>
COMMENTS	Became an illegal local dump in the 60s, cleared in 2012, and a perimeter bund installed to prevent livestock falling into the hole

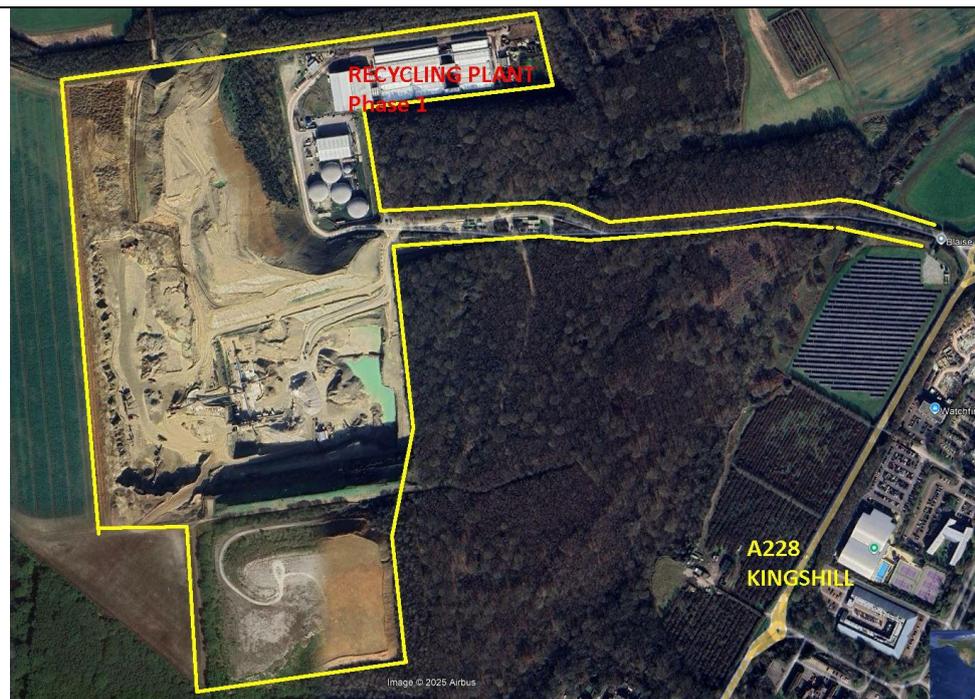
ADDRESS	Blaise Farm Quarry, Tower Hill, ME19 4PY
Geographical boundaries	West of A228 W Malling Bypass, south of St Blaise's Chapel (hist)
Operator/s	Gallagher Aggregates
Material Excavated	Ragstone,
Excavation Dates	1999 to date - ongoing
Landfill Dates	Ongoing
Landfill Material	overburden
Method	Unknown
Final Restoration Date	Unknown
Restored to	Ongoing
Restored to	Ongoing
Monitoring Regime	Blasting
COMMENTS	Mainly Offham PC, part Mereworth, access W Malling. 2013 approved Biogas generator to grid

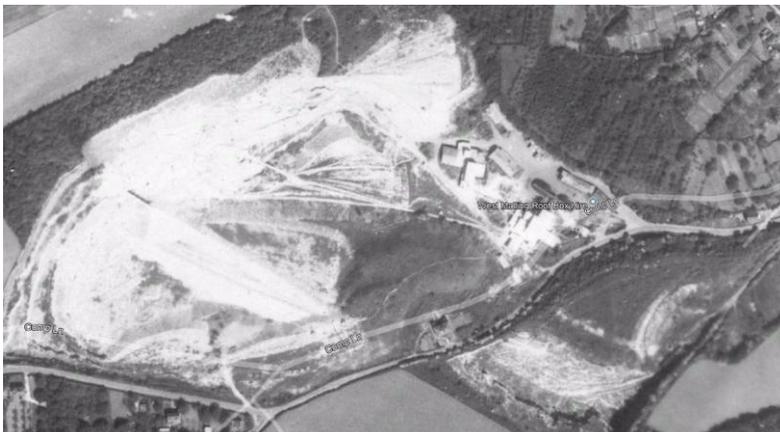
## OFFHAM SOUTH 1940

Since the original register was compiled, further reports backed up by this Google Historic image clearly show quarrying activity south of Comp Lane adjacent to the old southern entrance to the main quarry. Depth and fill unknown

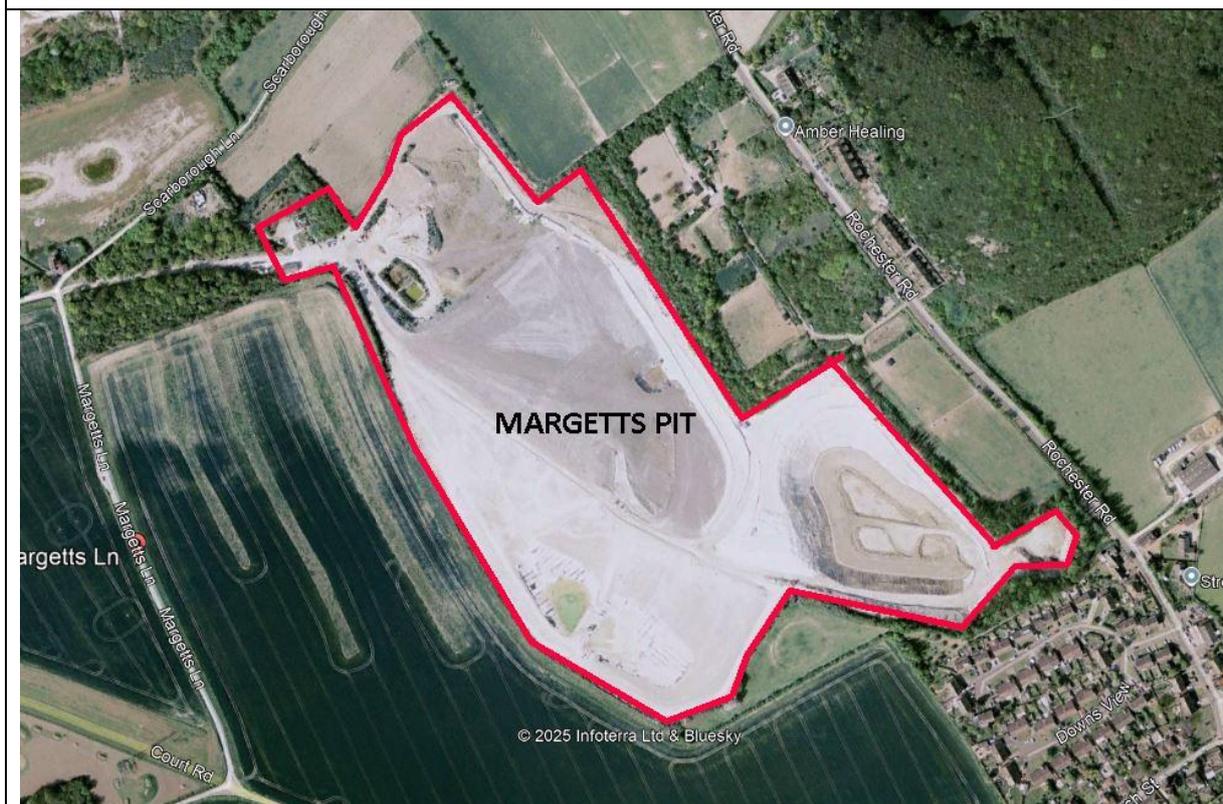
ADDRESS & Co-ordinates	Margetts Lane Burham TQ725622
Geographical boundaries	<i>Margetts Lane to northwest. Church Street to Southeast Rochester Road Burham to northeast. New Court Road to south</i>
Operator/s	
Material Excavated	<i>chalk,</i>
Excavation Dates	
Landfill Dates	<i>Up to mid 1990's</i>
Landfill Material	<i>Industrial waste,</i>
Method	<i>Edge tip,</i>
Final Restoration Date	<i>2000's</i>
Restored to	<i>Lower level</i>
Restored to	
Monitoring Regime	
COMMENTS	Ink waste from Reeds
