INFORMAL LANDFILL REGISTER - 2025

Including Contaminated Land and Flooded Excavations

TONBRIDGE & MALLING BOROUGH

Mike Taylor, Chairman, Borough Green Parish Council 2025 - with a lot of help from others
Formally Adopted by the Parish Partnership Panel 20 Nov 2025 & submitted to the Local Plan Evidence Base.

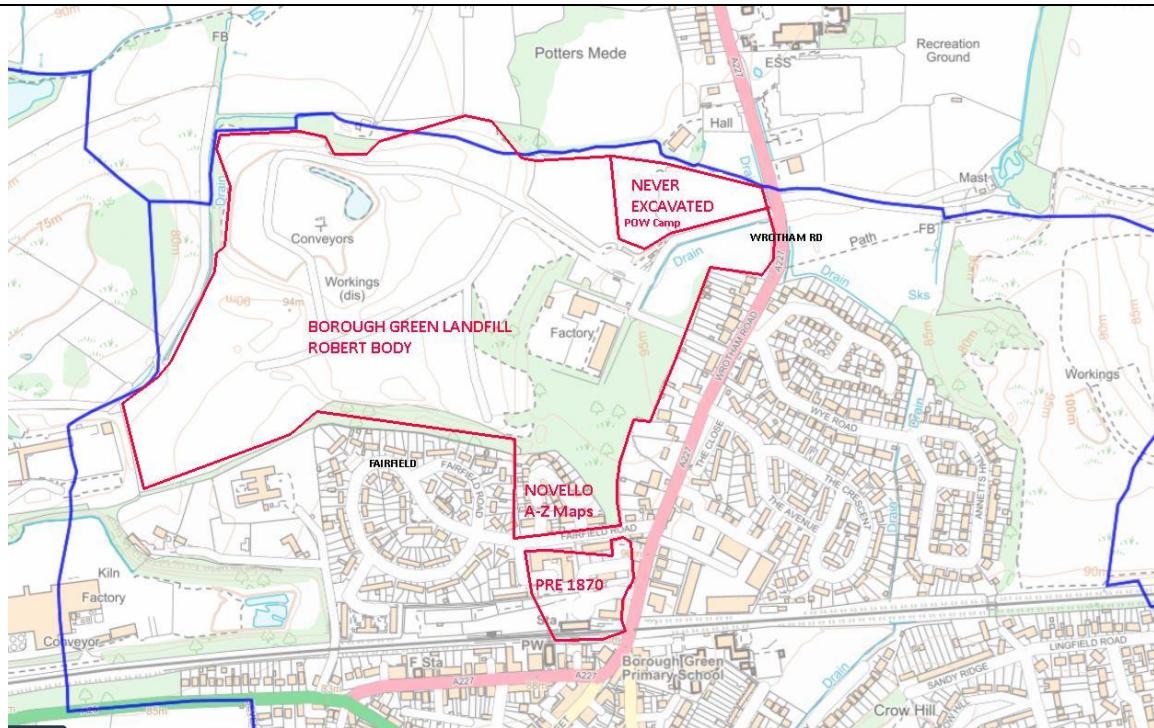
1

ADDRESS & Co-ordinates	Robert Body Haulage, Wrotham Rd BG
Geographical boundaries	<i>Ightham sandpit to West, Potters Mede & Westlands Farm to the north, Wrotham Rd to the east, Fairfield and Novello Close to the south</i>
Operator/s	Talbot, Halls, Cemex, Robert Body
Material Excavated	<i>Building sand</i>
Excavation Dates	<i>1880s to date, began prob 1820s, accelerated during railway building, which produced siding area</i>
Landfill Dates	<i>Ongoing, some prewar</i>
Landfill Material	<i>General & Industrial waste, latterly Inert waste,</i>
Method	<i>Edge tip until 2000, then engineered inert waste, recycling building material</i>
Final Restoration Date	<i>Unknown</i>
Restored to	<i>Planned to original landform</i>
Restored to	<i>Awaiting outcome</i>
Monitoring Regime	<i>EA. Site sits over aquifer - boreholes monitored by SEWater</i>
COMMENTS	Earlier areas unknown historic landfill, prewar. A-Z area asbestos problems. Comprehensive recycling operation for builders waste. 2025 Recycling machinery will have to be moved to surface to allow main excavation to be landfilled - noise problems will require bunding. NOTE - area in n/east corner never excavated, POW camp site until 1980

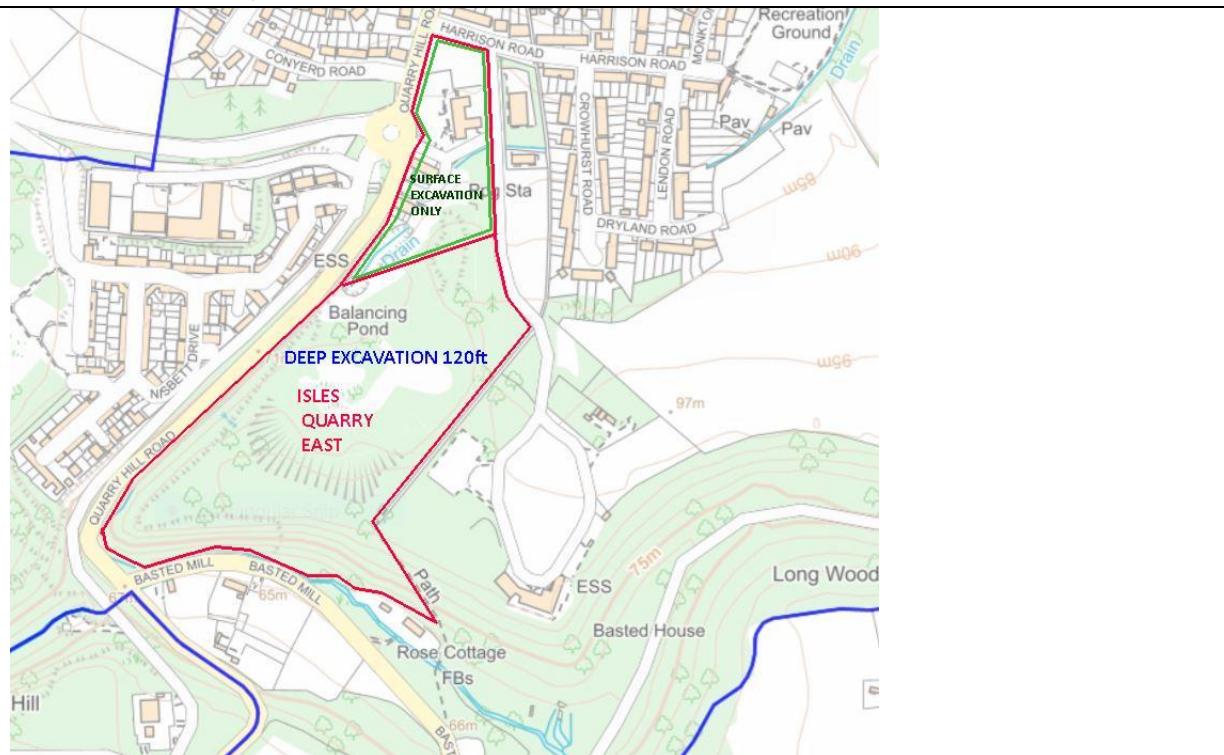
ADDRESS & Co-ordinates	Isles Quarry, Thong Lane Borough Green Now owned by BGPC, Amenity Land TM/94/155
Geographical boundaries	<i>North of Basted Lane, Woodland Estate and Basted House to the east and north, Thong lane to the west</i>
Operator/s	BQC, ARC, AMEY, Hanson, sold to Crest Nicholson for development
Material Excavated	<i>Kentish Ragstone, walling and roadstone.</i>
Excavation Dates	<i>Started Basted Lane, prob 1820-30, and moved north as far as Harrison Rd</i>
Landfill Dates	<i>Backfilled as excavation progressed</i>
Landfill Material	<i>Hassock, friable low grade limestone, by product of quarrying</i>
Method	<i>Just tipped, no topsoil ever introduced, despite planning condition in TM/94/155. Poor soil led to abundance of rare species</i>
Final Restoration Date	<i>Excavation stopped pre-war, large hole left as rifle range, and two large hassock heaps. eventually backfilled in 1980s when the hole was filled</i>

Restored to	<i>Southern half to lower level, north was never excavated to any depth and used for offices, sheds and lorry parking</i>
Restored to	<i>Some commercial, surgery & parking, some left to go wild</i>
Monitoring Regime	<i>None</i>
COMMENTS	<i>This is one of the few quarries in the area that is certifiably inert and safe.</i>

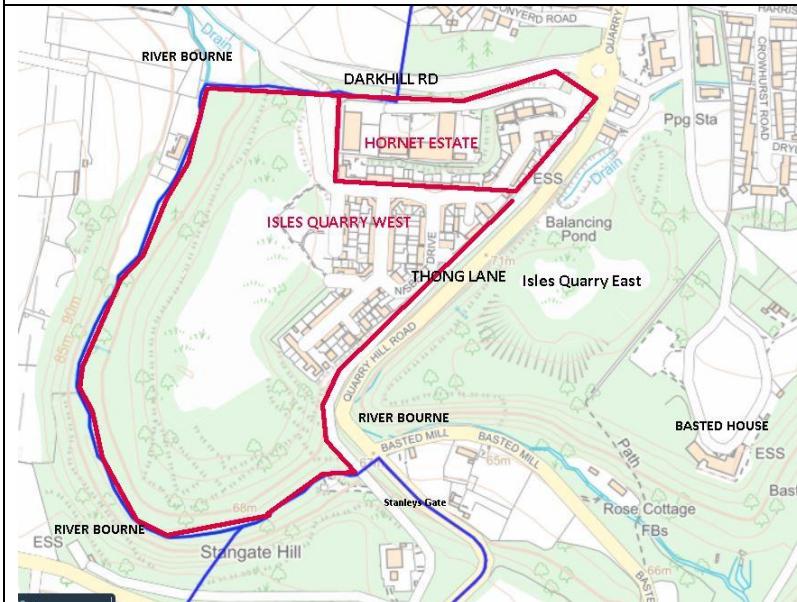
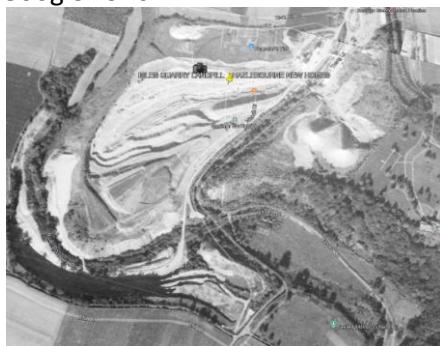
Google 1940

ADDRESS &	Thong Lane, Borough Green
Geographical boundaries	South of Darkhill Rd, West of Thong Lane, bounded on the south and west by the River Bourne
Operator/s	BQC, ARC, AMEY, HANSON, sold to Crest Nicholson for housing, built 2013
Material Excavated	Ragstone
Excavation Dates	Prob 1920s to 1945. Hornet Estate never excavated, but eastern part significant contamination from Sentinel coal ash, Tarmac Plant residues, and HGV oil & fuel deposits - buried illegally under housing area
Landfill Dates	1945 - 1960, some left until 1980s, large pond etc
Landfill Material	General, Industrial and Domestic Waste, silt from quarrying
Method	Edge tip,
Final Restoration Date	1980s
Restored to	Mostly original landform, some to lower level
Restored to	Commercial and housing
Monitoring Regime	Gas or watercourse, subsidence. None, but footings have gas membranes, and houses piled to prevent subsidence
COMMENTS	There was a tarmac plant built in the north east corner of the site in 1933, that generated significant coal ash and tarmac residues. The workshops to the west of that caused oil and fuel pollution. URS Scott Wilson survey in 2007 refers and sets out the remediation plan, which was not followed.

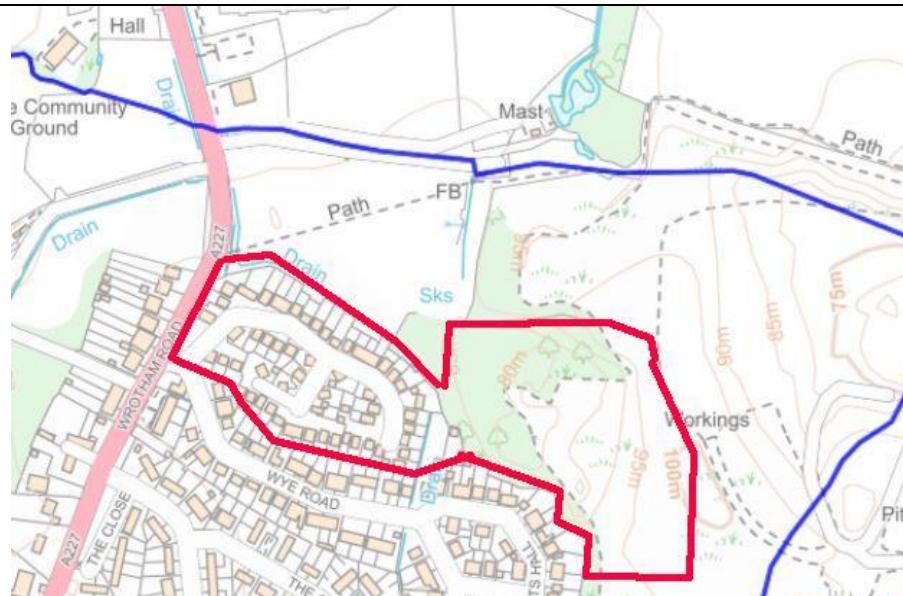
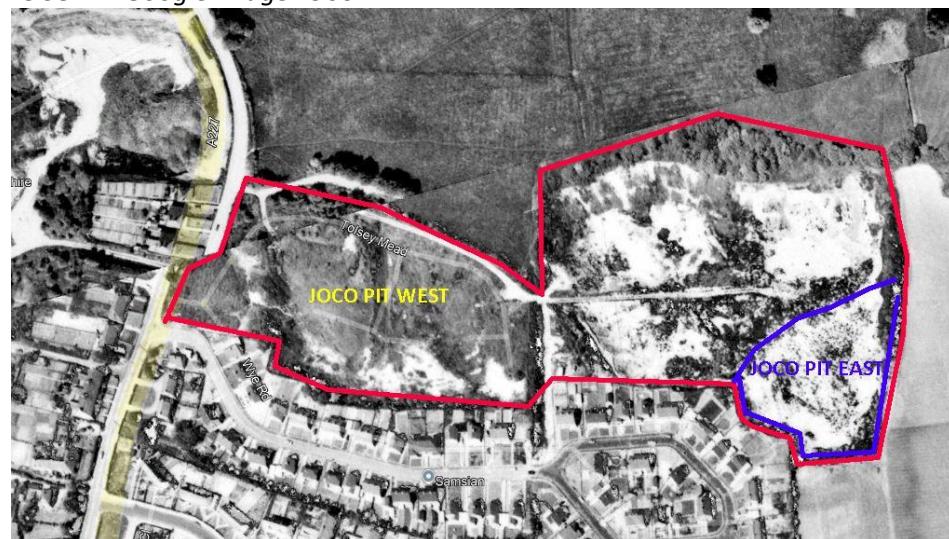
JOCO PIT Google image 1960

ADDRESS & Co-ordinates	Wrotham Rd, Borough Green
Geographical boundaries	<i>East of Wrotham Rd to boundary with BGSP, inc Tolsey Mead & Eaglestone Close, eastern end unfilled - wild lake</i>
Operator/s	John Naylor and Son, JOCO.
Material Excavated	<i>Soft Sand</i>
Excavation Dates	<i>1930s - 1950s</i>
Landfill Dates	<i>1950s-1970s</i>
Landfill Material	<i>General, builders and Domestic Waste, some abattoir waste</i>
Method	<i>Edge tip,</i>
Final Restoration Date	<i>Late 1960s</i>
Restored to	<i>Original landform, apart from eastern end, still open</i>
Restored to	<i>Housing and wild, River Bourne tributary diverted into pit</i>
Monitoring Regime	<i>Gas and subsidence ongoing</i>
COMMENTS	These houses have been built for 40 odd years, and still methane is being emitted. All houses have membranes

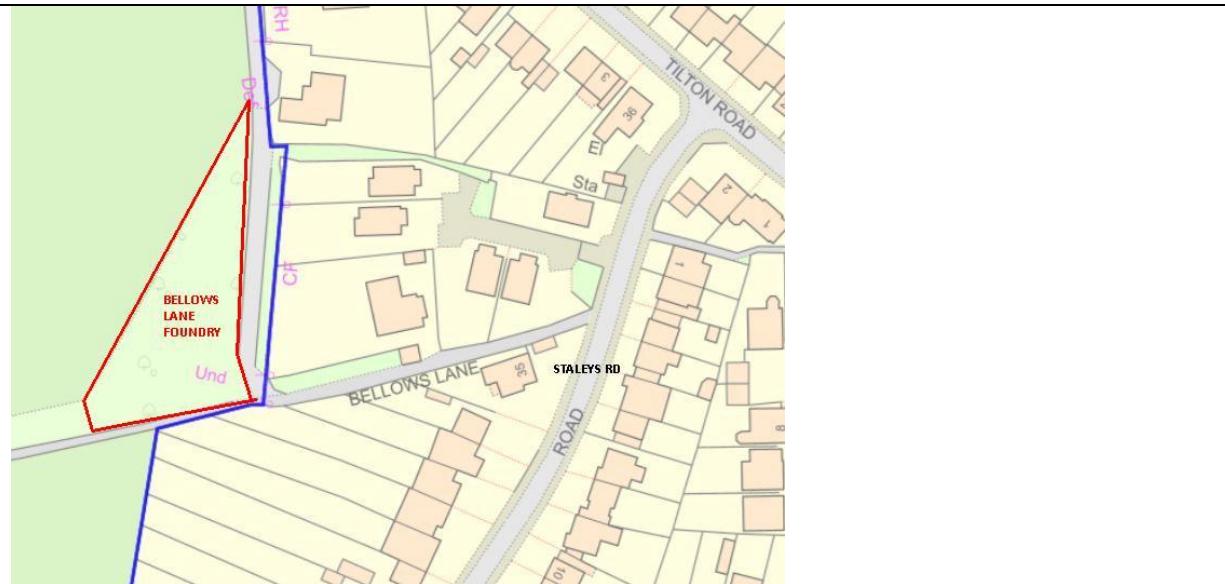
ADDRESS & Co-ordinates	Off Bellows Lane, Staleys Rd Borough Green
Geographical boundaries	<i>Corner of Darkhill Farm field</i>
Operator/s	Possibly Oxley, foundry until early 1900s
Material Excavated	<i>Sand and local ironstone</i>
Excavation Dates	<i>Late 1800s</i>
Landfill Dates	<i>Not landfilled, but cleared and landformed in 2012, safety bund</i>
Landfill Material	<i>Inert soil</i>
Method	
Final Restoration Date	?
Restored to	<i>Left at excavated level</i>
Restored to	<i>wild</i>
Monitoring Regime	<i>None</i>
COMMENTS	Became an illegal local dump in the 60s, cleared in 2012, and a perimeter bund installed to prevent livestock falling into the hole

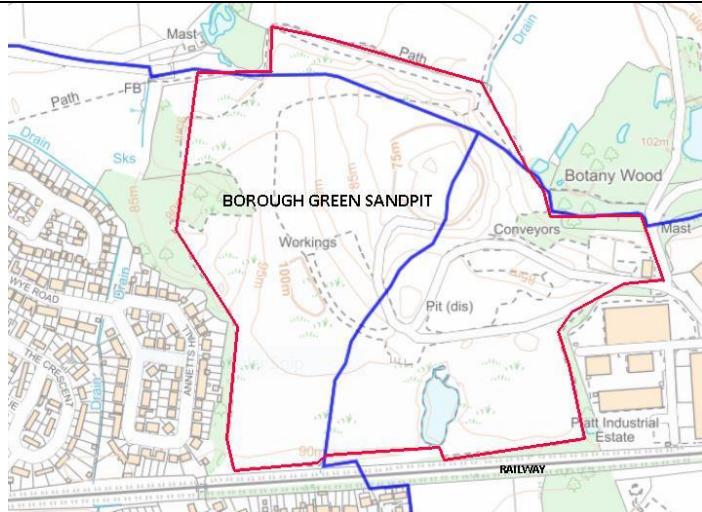
ADDRESS & Co-ordinates	North of Platt Ind Estate, Maidstone Rd, Platt
Geographical boundaries	<i>Railway to south, Annets Hall to the west, open fields, Botany Wood (anc) and PROW to the north, Platt Ind Est to the east</i>
Operator/s	Dennis Smith, Roger Body- Borough Green Sandpits
Material Excavated	<i>Soft sand</i>
Excavation Dates	<i>Late 60s, extraction still taking place 2025</i>
Landfill Dates	<i>Ongoing, proposed by 2030</i>
Landfill Material	<i>Inert waste, overburden</i>
Method	<i>Currently Engineered Fill, but early fill unmonitored</i>
Final Restoration Date	<i>2030?</i>
Restored to	<i>Original landform,</i>
Restored to	<i>Agricultural, but housing wanted by owner housing</i>
Monitoring Regime	<i>Occasional EA & KCC</i>
COMMENTS

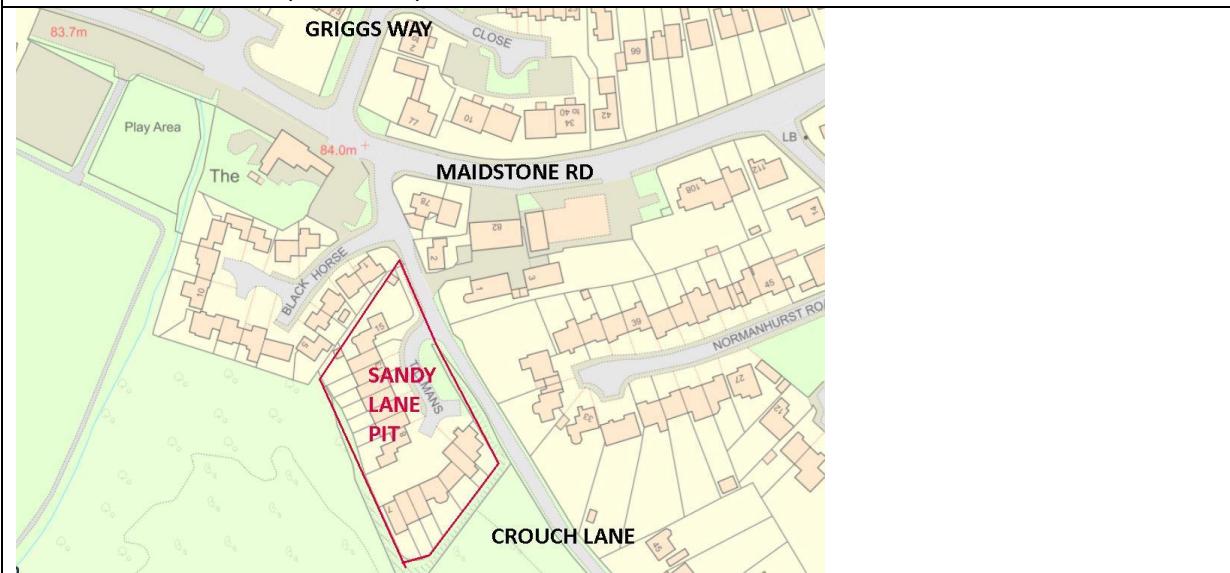
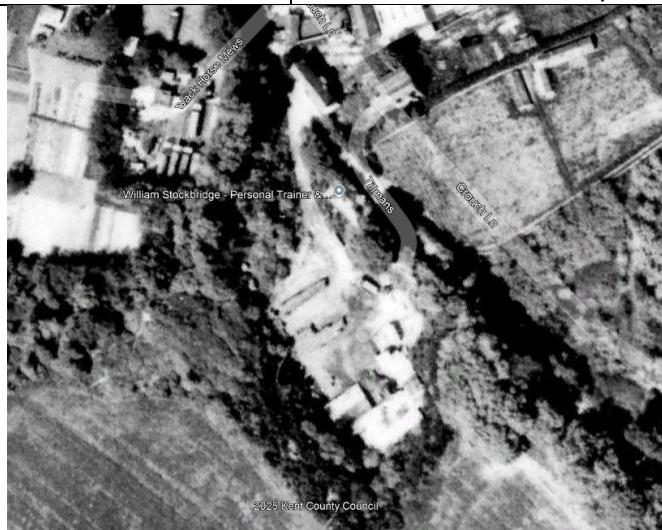
Tillmans, apx 1960

ADDRESS	Tillmans, off Crouch Lane
Boundaries	<i>West of Crouch Lane, south of Black Horse Mews</i>
Operator/s	Unknown
Material Excavated	<i>Building sand,</i>
Excavation Dates	<i>Unknown, probably early 1900s, this was a sand cliff, no deep excavation</i>
Landfill Dates	<i>unknown</i>
Landfill Material	<i>unknown</i>
Method	<i>unknown</i>
Final Restoration Date	
Restored to	<i>Local lower level</i>
Restored to	<i>Caravan Park, Antique Furniture factory, housing</i>
Monitoring Regime	
COMMENTS	The sandpit was occupied by a couple of local families in caravans, until Tillmans Antique restoration factory was built around probably in the 50s. This was replaced by the current Tillmans houses about 1990. Unlikely to hold any contaminated fill. Sandy Lane ran from Crouch Village past the Blackhorse, where Maidstone Rd is now, and up what is now Station Rd, but also used to be Sandy Lane.

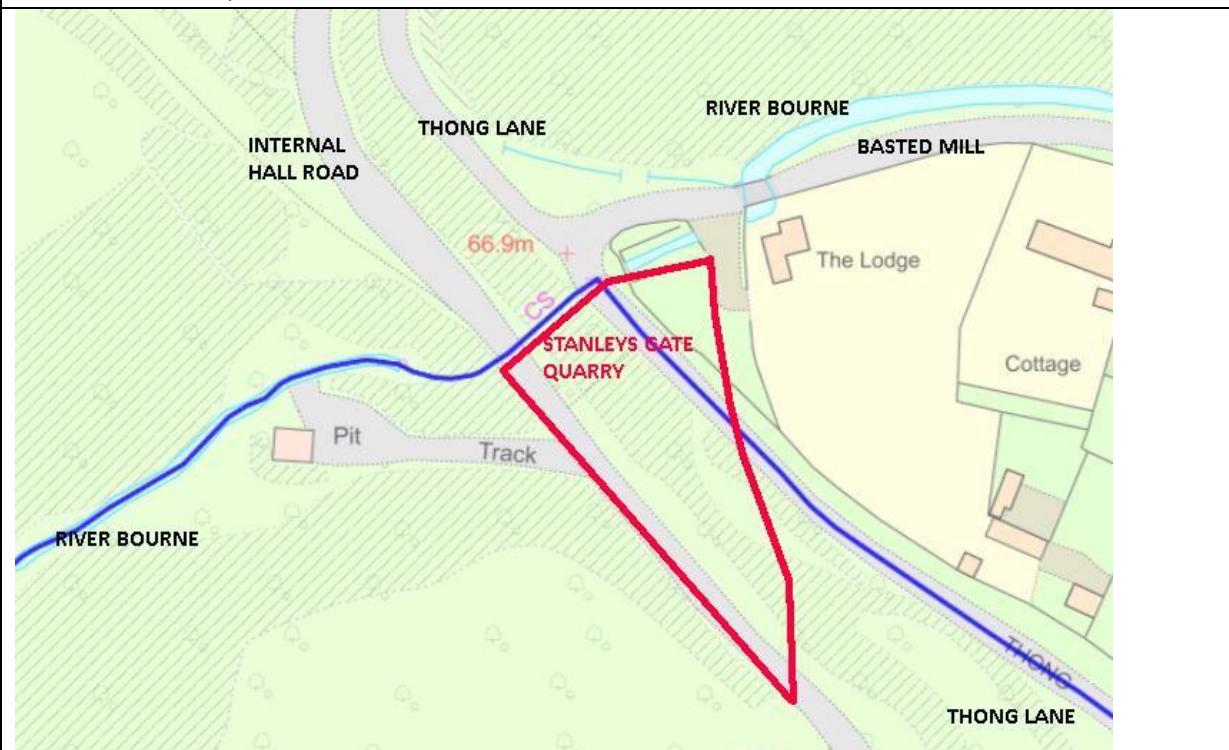
ADDRESS & Co-ordinates	Thong Lane, Borough Green
Geographical boundaries	<i>West of Thong Lane, subsumed into Stangate Quarry</i>
Operator/s	Unknown, presumed to be "Stanley"
Material Excavated	Ragstone,
Excavation Dates	1820s
Landfill Dates	n/a
Landfill Material	n/a
Method	n/a
Final Restoration Date	n/a
Restored to	n/a
Restored to	n/a
Monitoring Regime	n/a
COMMENTS	<p>This is the spot where quarrying began in the area, probably where the stone was exposed by river washout, and would have been used as building stone. When Isles Quarry East (Basted Quarry 1850) started on the other side of Basted Mill (Lane) it is presumed this was abandoned. Thong Lane was rerouted from its junction with Basted Mill at Basted Bridge, and cut across the abandoned quarry to the line we see today</p>

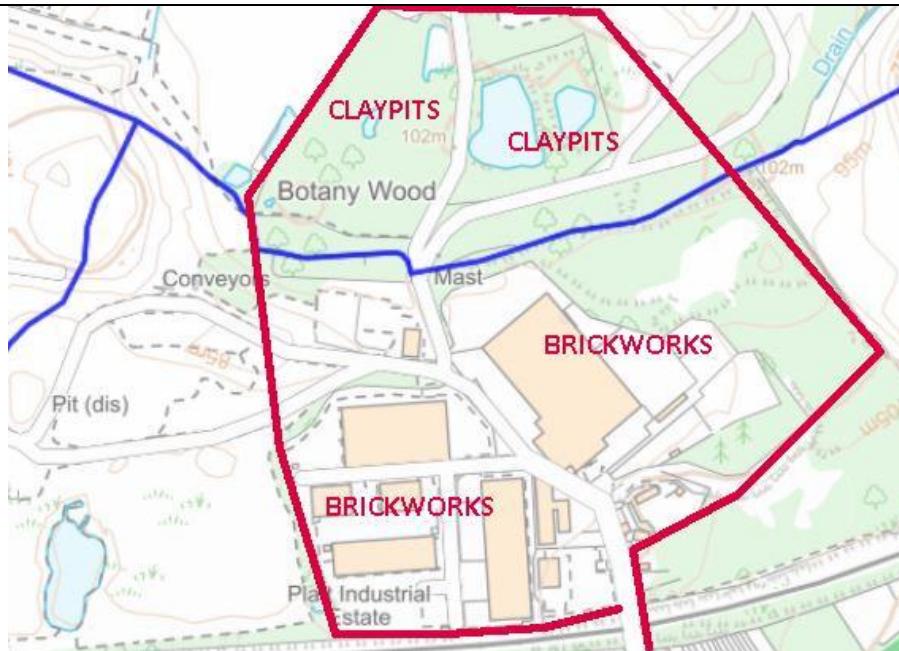
ADDRESS &	Sited on current Platt Ind Est
Geographical boundaries	<i>The entire estate site, some of Botany wood, inc claypits in Botany and the fishing pond - may even have been some from Park Farm</i>
Operator/s	Spencer - Builder and brickmaker from Platt, Hence Brickmakers Arms
Material Excavated	<i>clay</i>
Excavation Dates	<i>1860s - 1960s</i>
Landfill Dates	<i>none</i>
Landfill Material	<i>None</i>
Method	<i>n/a</i>
Final Restoration Date	<i>n/a</i>
Restored to	<i>n/a</i>
Restored to	<i>commercial,</i>
Monitoring Regime	<i>n/a</i>
COMMENTS

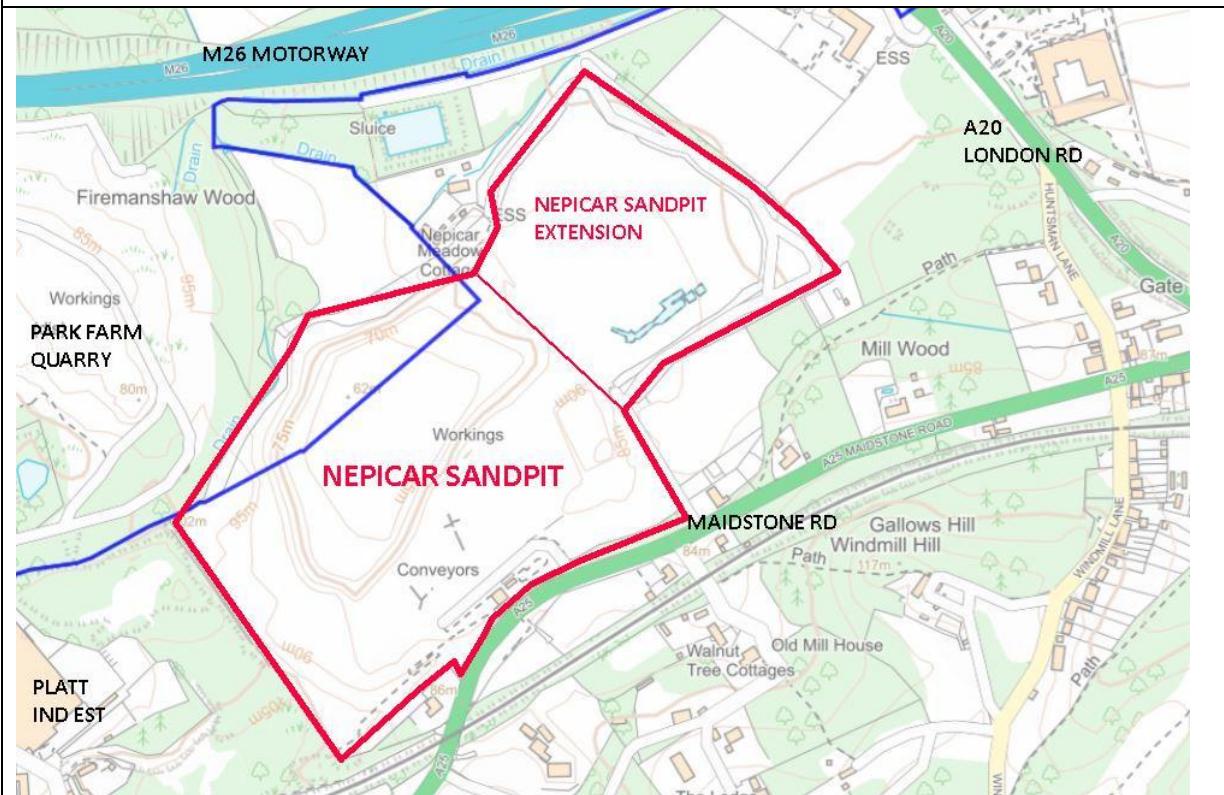
ADDRESS & Co-ordinates	Nepicar Sandpit, Maidstone Rd Platt
Geographical boundaries	<i>North of A25 Maidstone Rd, east of Platt Ind Est, south of Nepicar Meadow and M26,</i>
Operator/s	J Clubb, ?
Material Excavated	<i>Silica Foundry sand, building sand</i>
Excavation Dates	<i>2000</i>
Landfill Dates	<i>ongoing</i>
Landfill Material	<i>Inert waste, overburden</i>
Method	<i>Engineered Fill,</i>
Final Restoration Date	<i>ongoing</i>
Restored to	<i>n/a</i>
Restored to	<i>n/a</i>
Monitoring Regime	<i>n/a</i>
COMMENTS	Originally allowed as a source of scarce foundry silica sand, this was no longer required when Ford stopped casting at Dagenham, and so permission was granted to excavate sand for building, but problematic because of strata colour variation, mixing needed. Proposal to move 150,000 tonnes pa to H+H Celcon fell through when it was found it would not work in lightweight blocks. Recent application to go 2mtrs deeper across the site

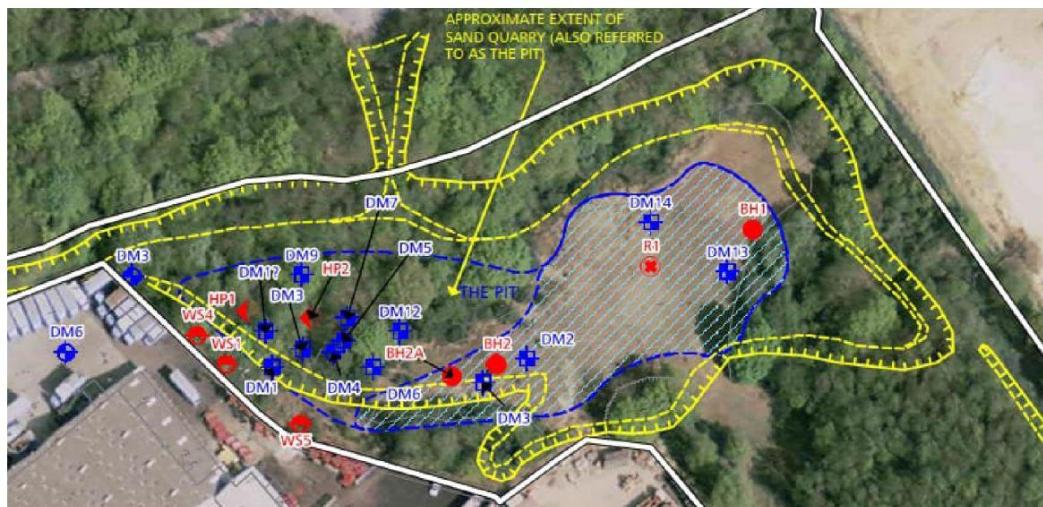
Figure 11: Remediation Method Statement for Asbestos Ground

ADDRESS	Access via Platt Industrial Estate or Nepicar Sandpit Maidstone Rd Platt
Geographical	East of Platt Ind Est, west of Nepicar sandpit
Operator/s	Operator Nepicar Sandpit Ltd, Landowner Espalier Properties
Material Excavated	Sand/Clay
Excavation Dates	Pascall's Brickyard since WWI. The full site will be the Western Extension to Nepicar Sandpit TM/27/01791. A Contamination Report by SLR Consulting used SOCOTEC to carry out intrusive investigation in the north of the site known colloquially as "The Pit". TP01 – composite sample containing 0.036% free chrysotile (white) asbestos fibres; BH01 - presence of loose asbestos fibres in 5 out of 6 no. samples. 0.006% to 0.03% free chrysotile fibres and 0.024% chrysotile lagging in Sample S2.
Landfill Dates	unknown
Landfill Material	Demolition materials from brickworks
Method	Unknown
Final Restoration Date	Unknown
Restored to	Local level - scrubland
Monitoring Regime	EA/KCC now advised in App TM/25/01791

COMMENTS	NSQ have a comprehensive remediation plan in place, but how has this been missed by TMBC?

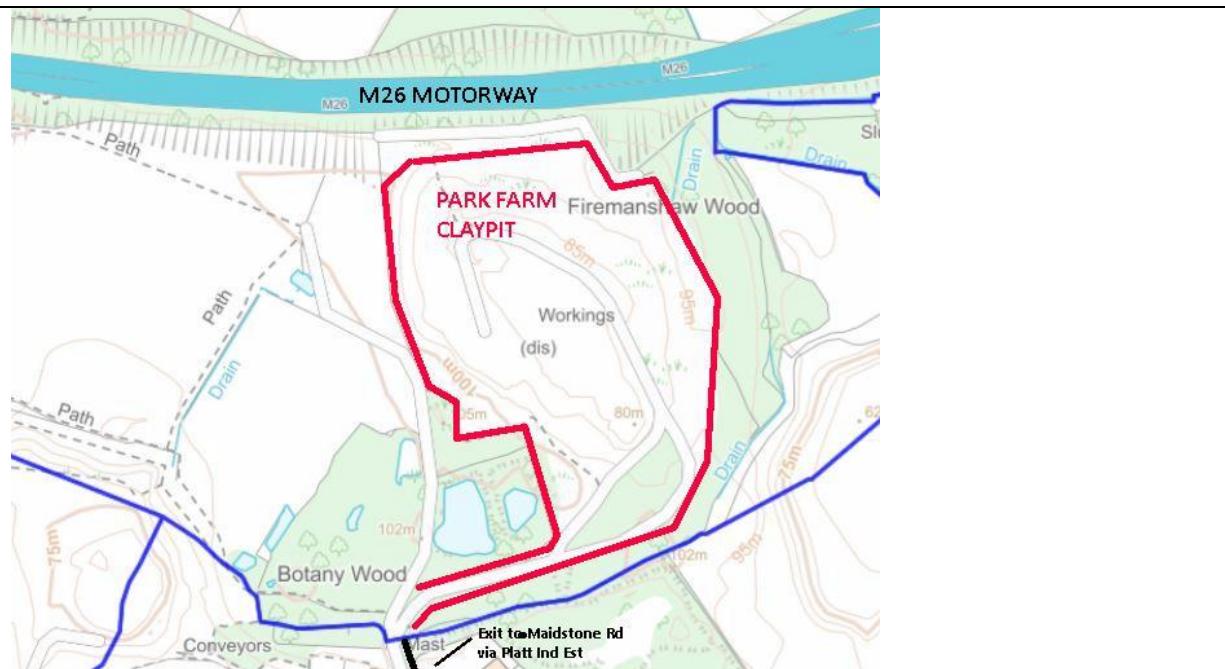
ADDRESS & Co-ordinates	Access via Platt Industrial Estate, Maidstone Rd Platt
Geographical boundaries	<i>North of Platt Ind Est, west of Nericar sandpit</i>
Operator/s	(Spencer) Halls, Echoraise
Material Excavated	clay
Excavation Dates	<i>It is possible it was opened up for brick clay by the Spencer Brickworks, but was in recent times operated by Hall Aggregates to supply Rugby Cement at Halling. It has lain idle for some years, but there has been a recent application to remove more clay, and there is an extant permission for sand until 2042</i>
Landfill Dates	<i>n/a</i>
Landfill Material	<i>n/a</i>
Method	<i>n/a</i>
Final Restoration Date	<i>n/a</i>
Restored to	<i>n/a</i>
Restored to	<i>n/a</i>
Monitoring Regime	<i>n/a</i>
COMMENTS

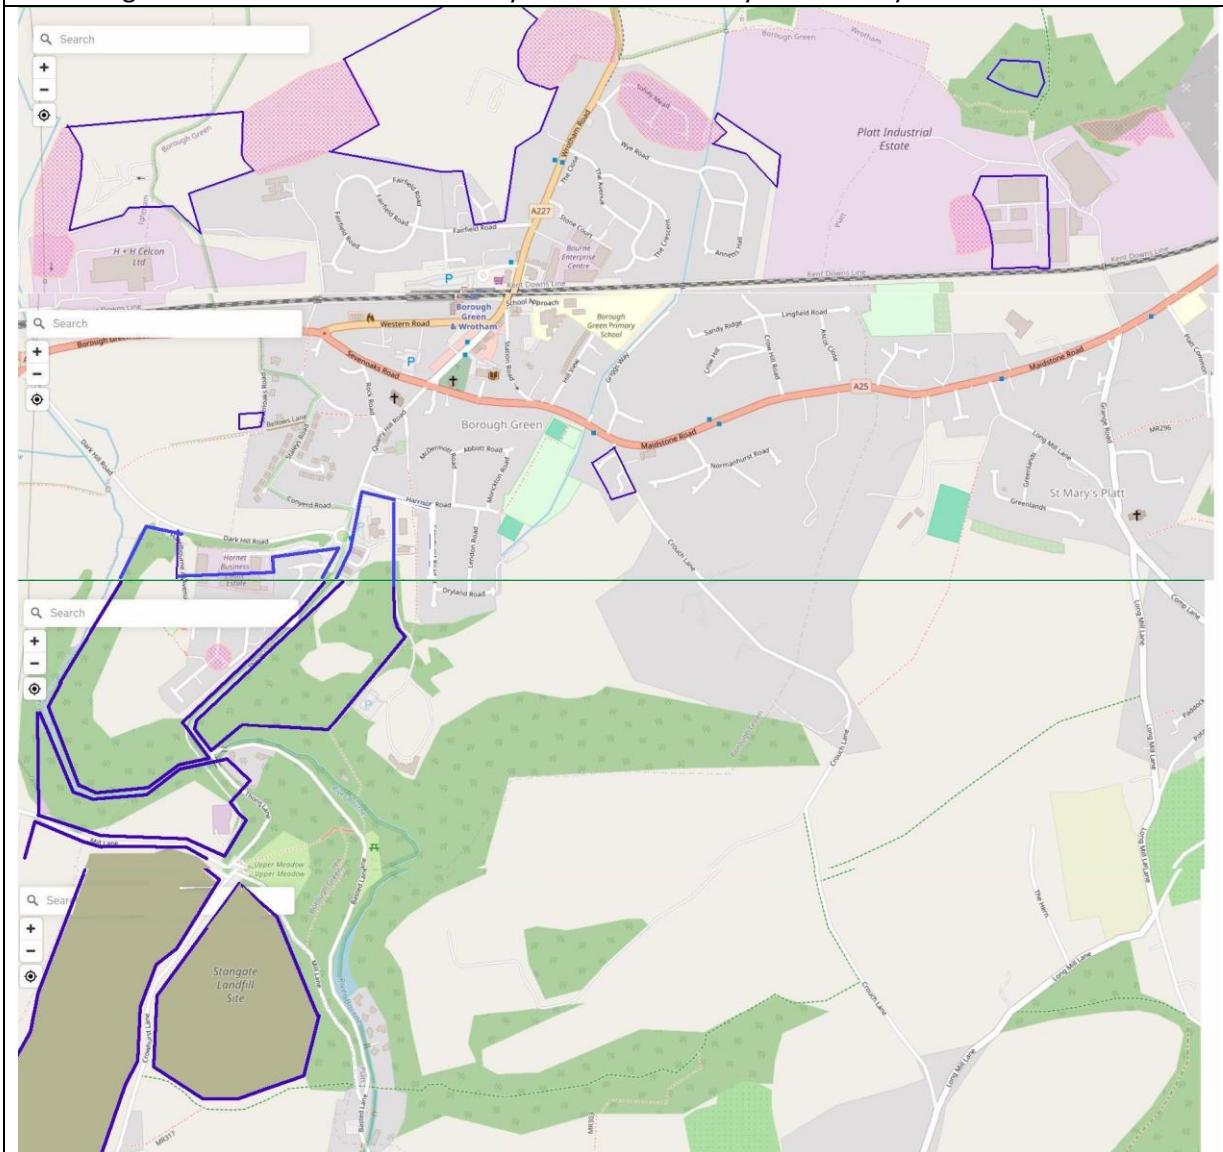
Areas marked brown and pink are the landfills/quarries in their records

Areas edged in blue are landfills known by us but not officially recorded by them.

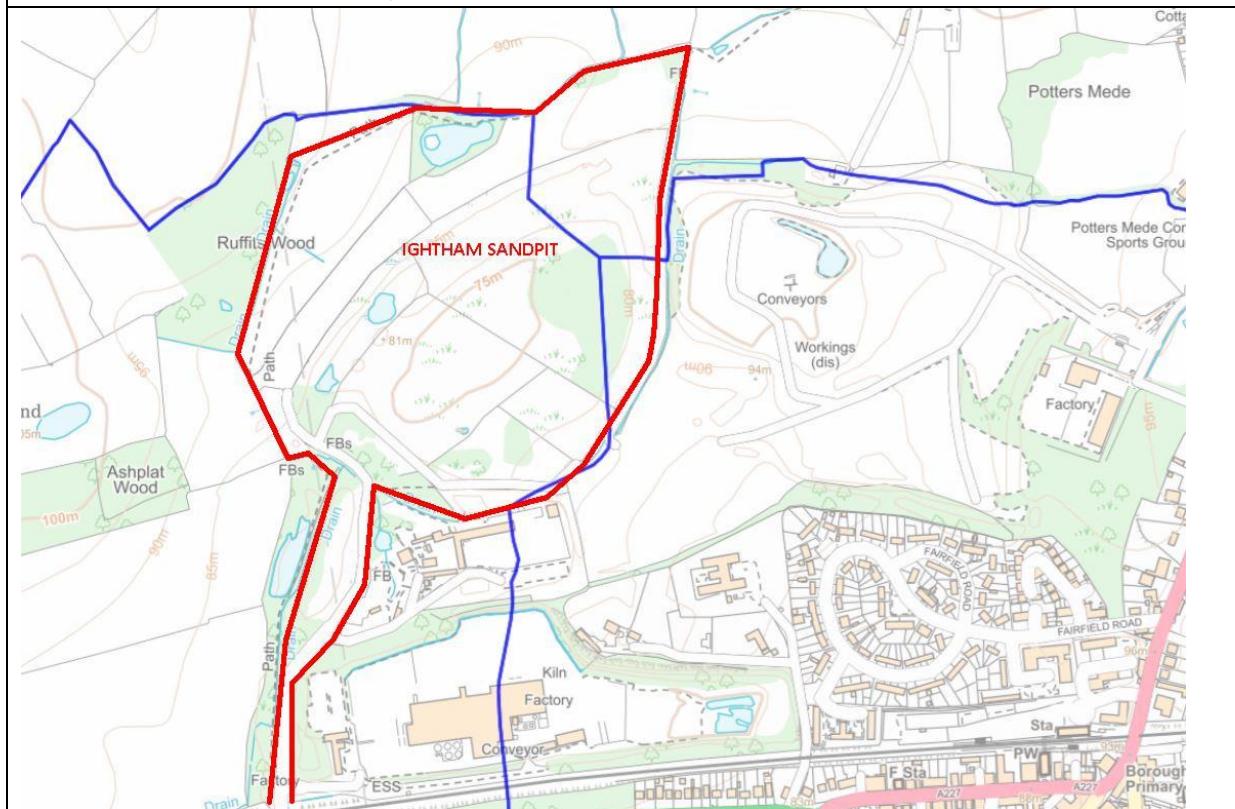
ADDRESS & Co-ordinates	Borough Green Rd Ightham
Geographical boundaries	<i>West of BG Landfill, South of Westlands farm, east of BGLF, north of Cricketts Farm and H+H Celcon</i>
Operator/s	Sevenoaks Brick, Kent White Brick, H+H Celcon (Trodell Plant)
Material Excavated	<i>Soft sand</i>
Excavation Dates	<i>Late 70s to late 80s</i>
Landfill Dates	<i>Late 90s</i>
Landfill Material	<i>Industrial waste, probably illegally imported from BP IOG refinery remediation</i>
Method	<i>Edge tip, capped with hassock from Stangate to form Bypass Route</i>
Final Restoration Date	<i>Natural wilding has occurred, ponds, factory "hole" still open, beautiful ponds and woodland developing</i>
Restored to	<i>Original landform, and lower level</i>
Restored to	<i>Open wild land</i>
Monitoring Regime	<i>Occasional - EA & KCC unaware of landfill completion</i>
COMMENTS	Some 200,000 cu mtrs of hazardous refinery waste destined for Pitsea was diverted here illegally, capped with Hassock during the Stangate restoration in the 90s. Intrusive survey by Southern Testing in 2006 shows significant "foreign bodies", steel drums, and hydrocarbons. KCC have not responded to a request for landfill records, and the EA historic Landfill website shows nothing

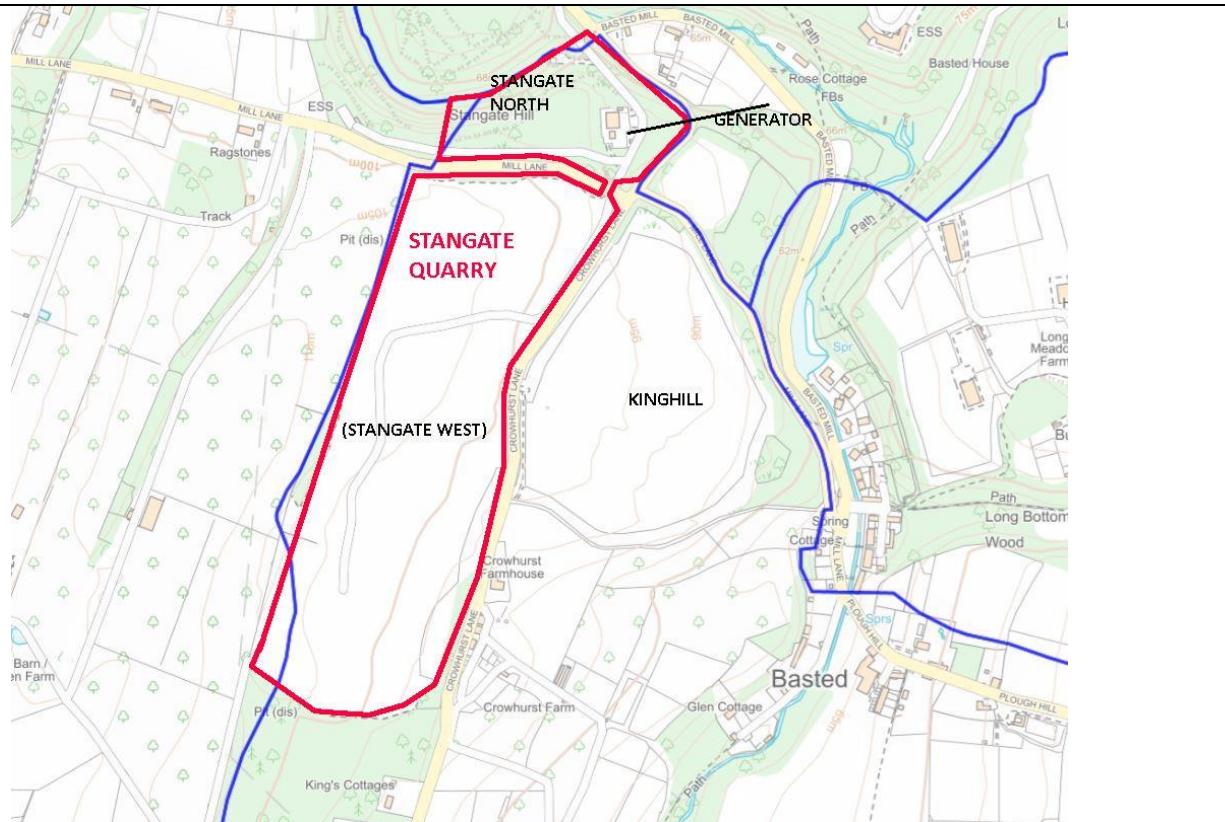
ADDRESS & Co-ordinates	Crowhurst Lane, Plaxtol
Geographical	<i>West of Crowhurst Lane, south and north of Mill Lane</i>
Operator/s	ARC, WRG,
Material Excavated	<i>Stone, ARC constructed a bridge under Mill Lane for access</i>
Excavation Dates	<i>1970 - 1980</i>
Landfill Dates	<i>1980 - 90</i>
Landfill Material	<i>London Domestic Waste</i>
Method	<i>Engineered Fill, cell and cap. methane extraction built in</i>
Final Restoration Date	<i>Ongoing, subsidence infill when necessary</i>
Restored to	<i>Original landform,</i>
Restored to	<i>Agricultural, Planned Solar Farm</i>
Monitoring Regime	<i>Gas and subsidence</i>
COMMENTS	<p>Methane is extracted and piped to a generator north of Mill Lane, and power sent to the National Grid via a sub-station on Mill Lane.</p> <p>Limestone excavation ended when ragstone levels fell to 35%, the remainder being hassock, a low grade friable limestone that is an inert and suitable stable fill,</p> <p>Whilst the southern area and Kinghill were very carefully cell and cap landfilled, northern areas were backfilled with unknown materials, but probably hassock, but there may be unknown pockets of other unmonitored waste. A considerable amount of silt laden water from the stone washing process was discharged into the River Bourne, leading to massive silting (est 10,000 cu mtrs) of Basted Mill pond, now only a few feet deep from its original 30ft depth</p>

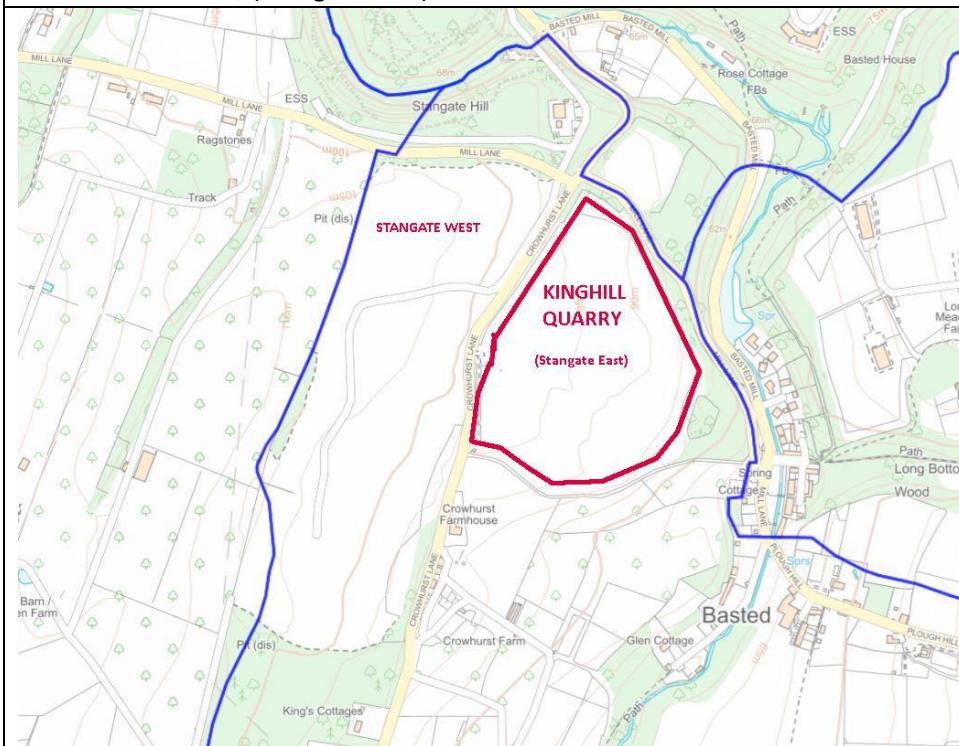
ADDRESS & Co-ordinates	Crowhurst Lane, Plaxtol
Geographical boundaries	<i>East of Crowhurst Lane, south of Mill Lane</i>
Operator/s	ARC, WRG,
Material Excavated	<i>Stone, ARC constructed a bridge under Crowhurst lane for access</i>
Excavation Dates	<i>1970 - 1980</i>
Landfill Dates	<i>1980 - 90</i>
Landfill Material	<i>London Domestic Waste</i>
Method	<i>Engineered Fill, cell and cap. methane extraction built in</i>
Final Restoration Date	<i>Ongoing, subsidence infill when necessary</i>
Restored to	<i>Original landform,</i>
Restored to	<i>Agricultural, Planned Solar Farm</i>
Monitoring Regime	<i>Gas and subsidence</i>
COMMENTS	Methane is extracted and piped to a generator north of Mill Lane, and power sent to the National Grid via a sub-station on Mill Lane. Limestone excavation ended when ragstone levels fell to 35%, the remainder being hassock, a low grade friable limestone that is an inert and suitable stable fill. Whilst the southern area and Kinghill were very carefully cell and cap landfilled, northern areas were backfilled with unknown materials, but probably hassock, but there may be unknown pockets of other unmonitored waste. A considerable amount of silt laden water from the stone washing process was discharged into the River Bourne, leading to massive silting of Basted Mill pond, now only a few feet deep from its original 30ft depth

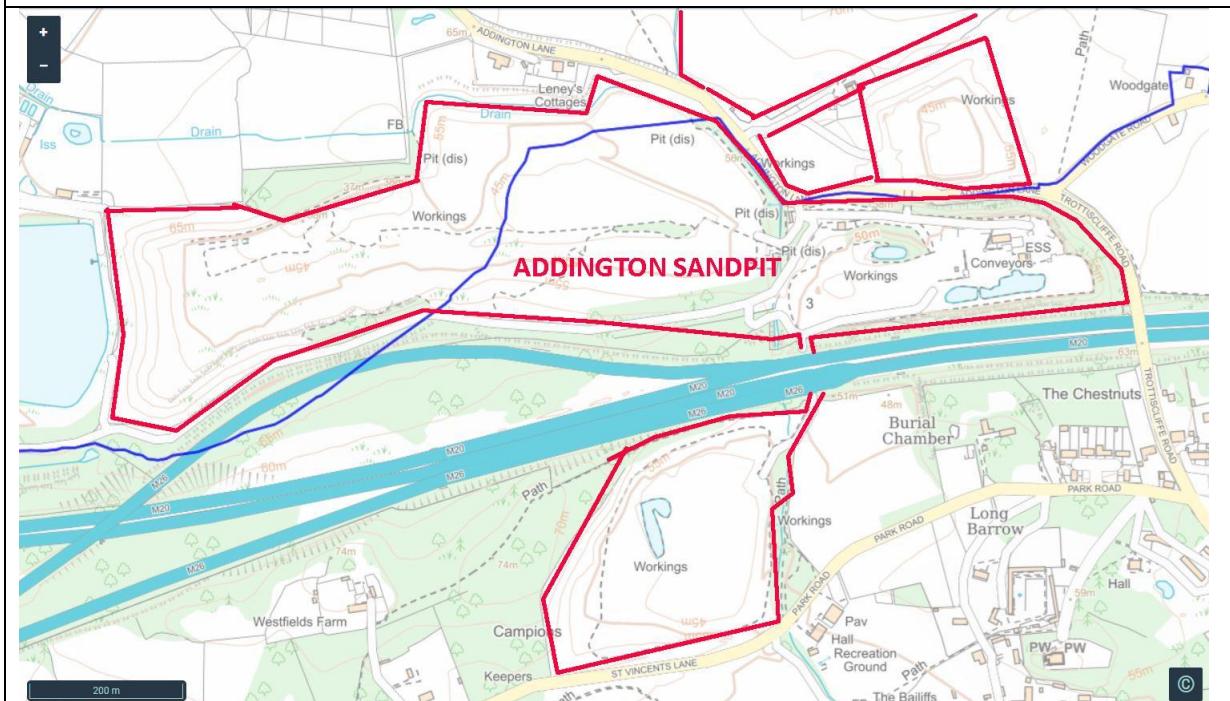
ADDRESS & Co-ordinates	Addington Sandpit, Addington Lane, Trottiscliffe and Addington
Geographical boundaries	North & South of M20/M26, north and south of Addington Lane
Operator/s	Olleys, Ferns
Material Excavated	Foundry Sand, building sand,
Excavation Dates	
Landfill Dates	
Landfill Material	<i>General waste. Industrial waste, Domestic Waste, Inert waste, overburden</i>
Method	<i>Edge tip, Engineered Fill, cell and cap</i>
Final Restoration Date	
Restored to	<i>Original landform, local level, lower level</i>
Restored to	<i>Agricultural, woodland, commercial, housing</i>
Monitoring Regime	<i>Gas or watercourse, subsidence</i>
COMMENTS

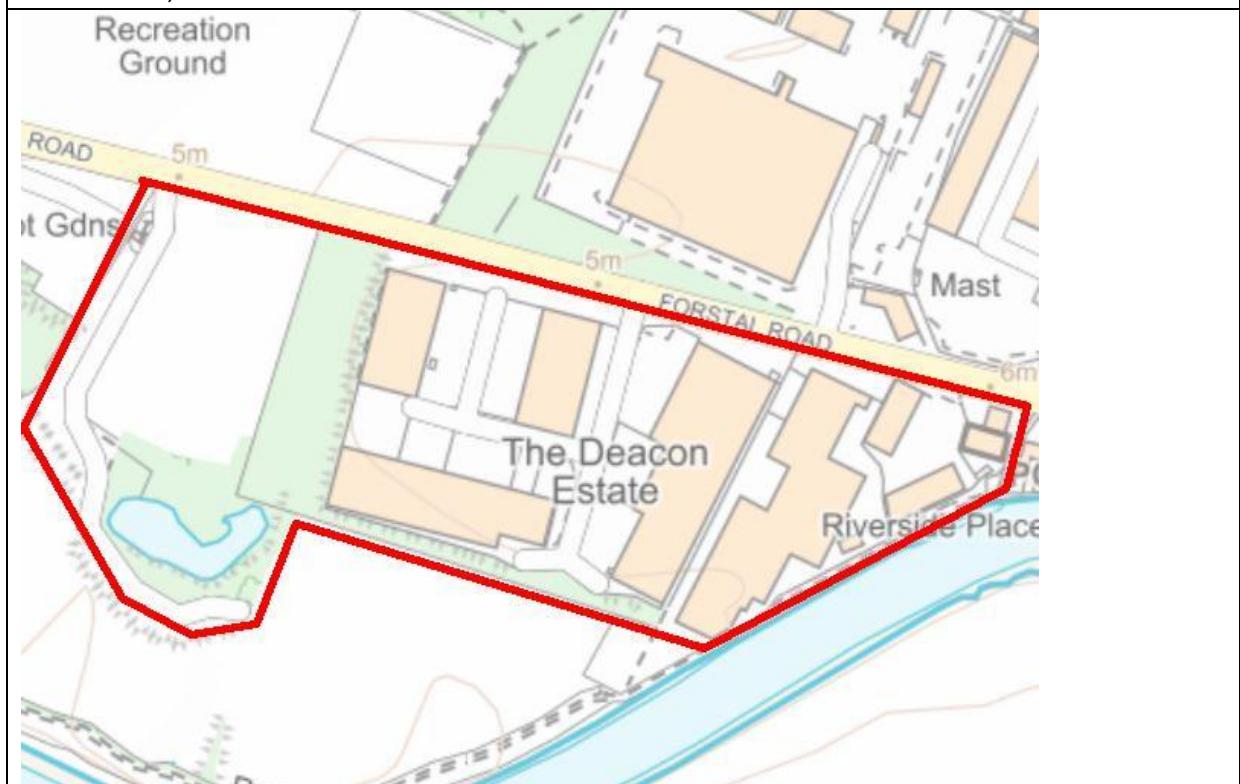
ADDRESS & Co-ordinates	Deacon Estate, Forstal Road, Aylesford TQ733584
Geographical boundaries	Forstal Road to north. Aylesford village to west. River Medway to south and east
Operator/s	
Material Excavated	River gravel
Excavation Dates	Up to 1950's
Landfill Dates	About 1950's
Landfill Material	<i>Waste soils tapped off with old road construction materials from the M20 (Sittingbourne Road to Thurnham Lane section failed and had to be rebuilt)</i>
Method	<i>Tipped and bulldozed level</i>
Final Restoration Date	1980's
Restored to	<i>Original level</i>
Restored to	
Monitoring Regime	<i>Gas vents installed alongside the warehouses</i>
COMMENTS

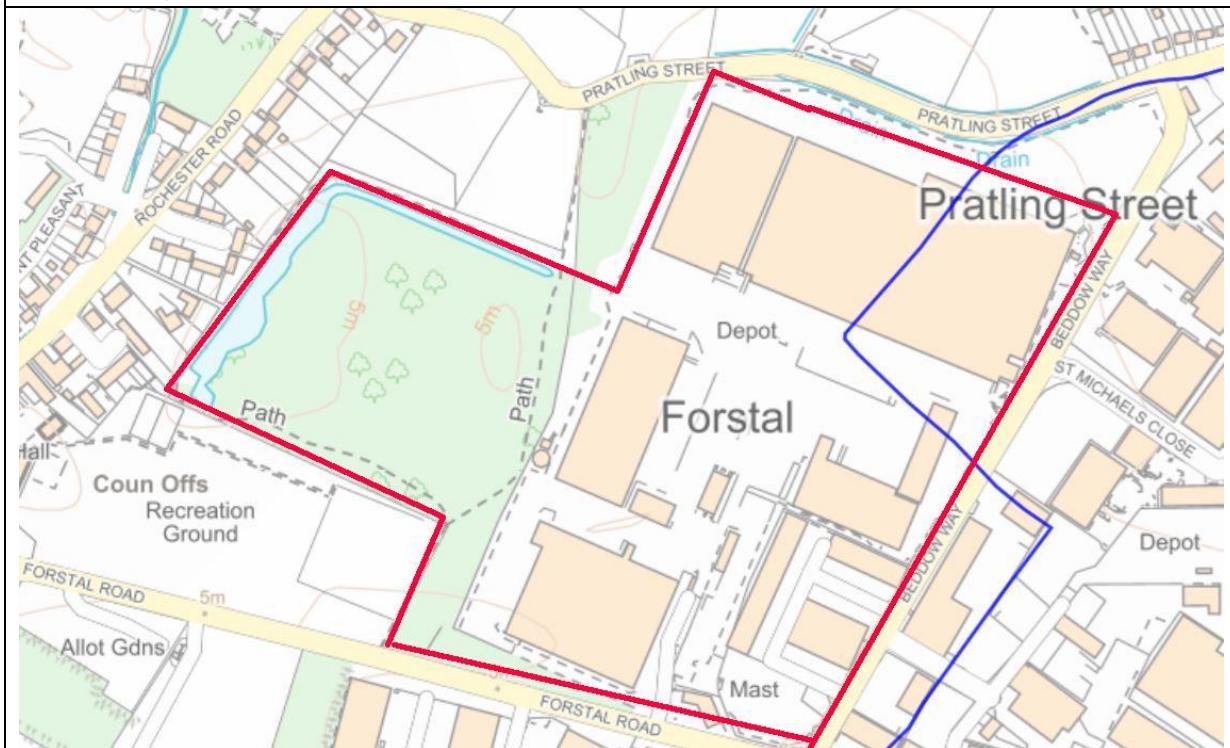
ADDRESS& Co-ordinates	Yoakley Land and Waitrose warehouses TQ735591
Geographical boundaries	<i>Forstal Road to the south. Aylesford village to the west, Pratling Street to the north. Beddow Way to the east</i>
Operator/s	
Material Excavated	<i>Flood Plain gravels</i>
Excavation Dates	<i>1945-1950</i>
Landfill Dates	<i>1950's</i>
Landfill Material	<i>General Waste, Boiler Ash, Pulverised Fly Ash</i>
Method	<i>Tipped</i>
Final Restoration Date	<i>Not restored</i>
Restored to	
Restored to	
Monitoring Regime	<i>none</i>
COMMENTS	May or may not extend north to Pratling Street

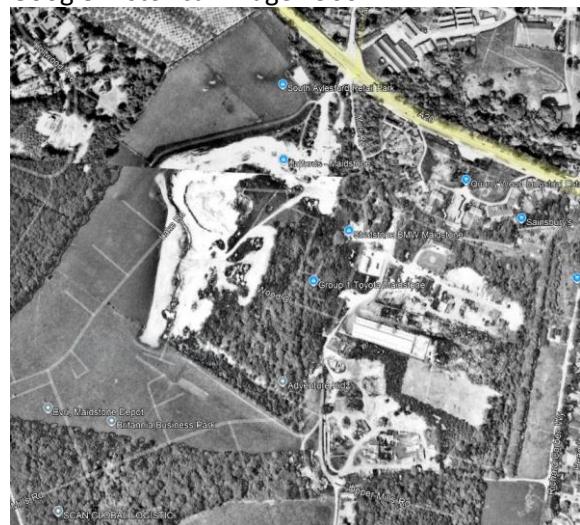
Google Historical Image 1960

ADDRESS & Co-ordinates	Now South Aylesford Retail Park (Quarry Wood Ind Est)
Geographical boundaries	South of London Rd, West of Hermitage Lane
Operator/s	Mills
Material Excavated	Ragstone
Excavation Dates	1940s - 1960s
Landfill Dates	Unknown
Landfill Material	Unknown
Method	Unknown
Final Restoration Date	1960s
Restored to	Original landform,
Restored to	Commercial, Retail
Monitoring Regime	Unknown
COMMENTS

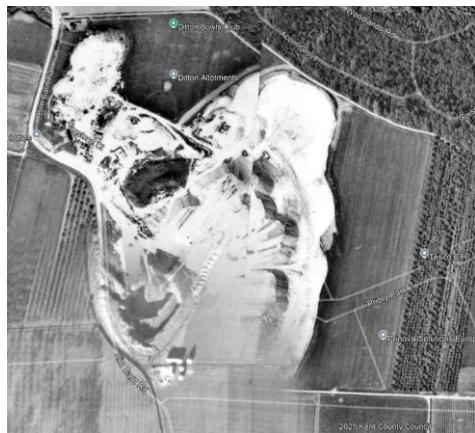
GOOGLE IMAGES 1960

ADDRESS & Co-ordinates	Kiln Barn Rd , Ditton
Geographical boundaries	East of Kiln Barn Rd, West of Quarry Wood Industrial Estate
Operator/s	Val De Travers
Material Excavated	Ragstone
Excavation Dates	Two phases 1960s - 1980, & 1980-1990
Landfill Dates	Following excavation
Landfill Material	Unknown
Method	Unknown
Final Restoration Date	By mid-90s
Restored to	Original landform,
Restored to	Woodland and open space, commercial, housing
Monitoring Regime	Unknown
COMMENTS

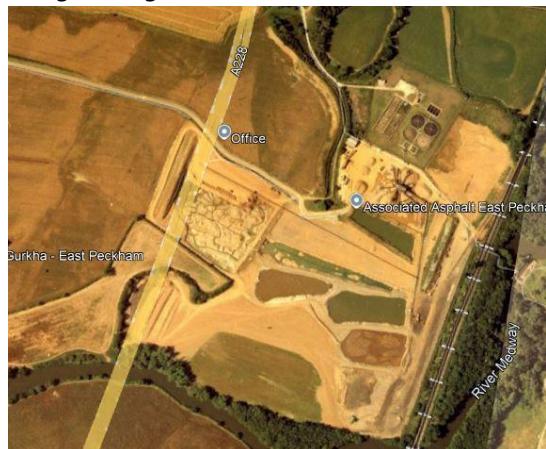
Google Images c1990

ADDRESS & Co-ordinates	Boyle Way East Peckham
Geographical boundaries	East of Boyle Way A228 EP Bypass, west of railway
Operator/s	Clubbs, Unknown
Material Excavated	Sand?
Excavation Dates	1960-1990s south section, 1990s-2020s north section
Landfill Dates	Following excavations
Landfill Material	Unknown
Method	Unknown
Final Restoration Date	Unknown
Restored to	Original landform
Restored to	Agricultural, some remaining commercial railway sidings
Monitoring Regime	Unknown
COMMENTS	PFA imported for H+H Celcon

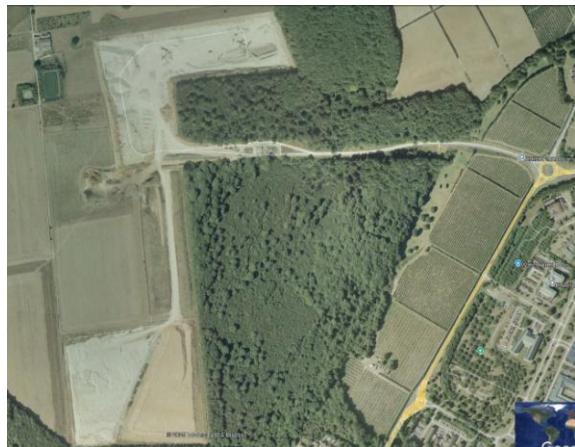
Blaise Farm 2003

ADDRESS	Blaise Farm Quarry, Tower Hill, ME19 4PY
Geographical boundaries	West of A228 W Malling Bypass, south of St Blaise's Chapel (hist)
Operator/s	Gallagher Aggregates
Material Excavated	Ragstone,
Excavation Dates	1999 to date - ongoing
Landfill Dates	Ongoing
Landfill Material	overburden
Method	Unknown
Final Restoration Date	Unknown
Restored to	Ongoing
Restored to	Ongoing
Monitoring Regime	Blasting
COMMENTS	Mainly Offham PC, part Mereworth, access W Malling. 2013 approved Biogas generator to grid
