INFORMAL LANDFILL REGISTER - 2025

Including Contaminated Land and Flooded Excavations

TONBRIDGE & MALLING BOROUGH

Mike Taylor, Chairman, Borough Green Parish Council 2025 - with a lot of help from others
Formally Adopted by the Parish Partnership Panel 20 Nov 2025 & submitted to the Local Plan Evidence Base.

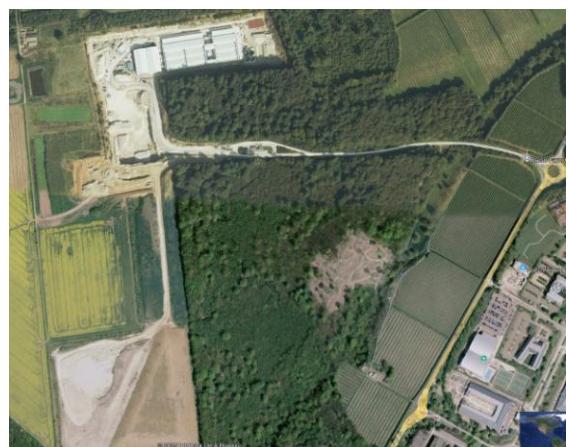
2009

ADDRESS	Blaise Farm Quarry, Tower Hill, ME19 4PY
Geographical boundaries	West of A228 W Malling Bypass, south of St Blaise's Chapel (hist)
Operator/s	Gallagher Aggregates
Material Excavated	Ragstone,
Excavation Dates	1999 to date - ongoing
Landfill Dates	Ongoing
Landfill Material	overburden
Method	Unknown
Final Restoration Date	Unknown
Restored to	Ongoing
Restored to	Ongoing
Monitoring Regime	Blasting
COMMENTS	Mainly Offham PC, part Mereworth, access W Malling. 2013 approved Biogas generator to grid

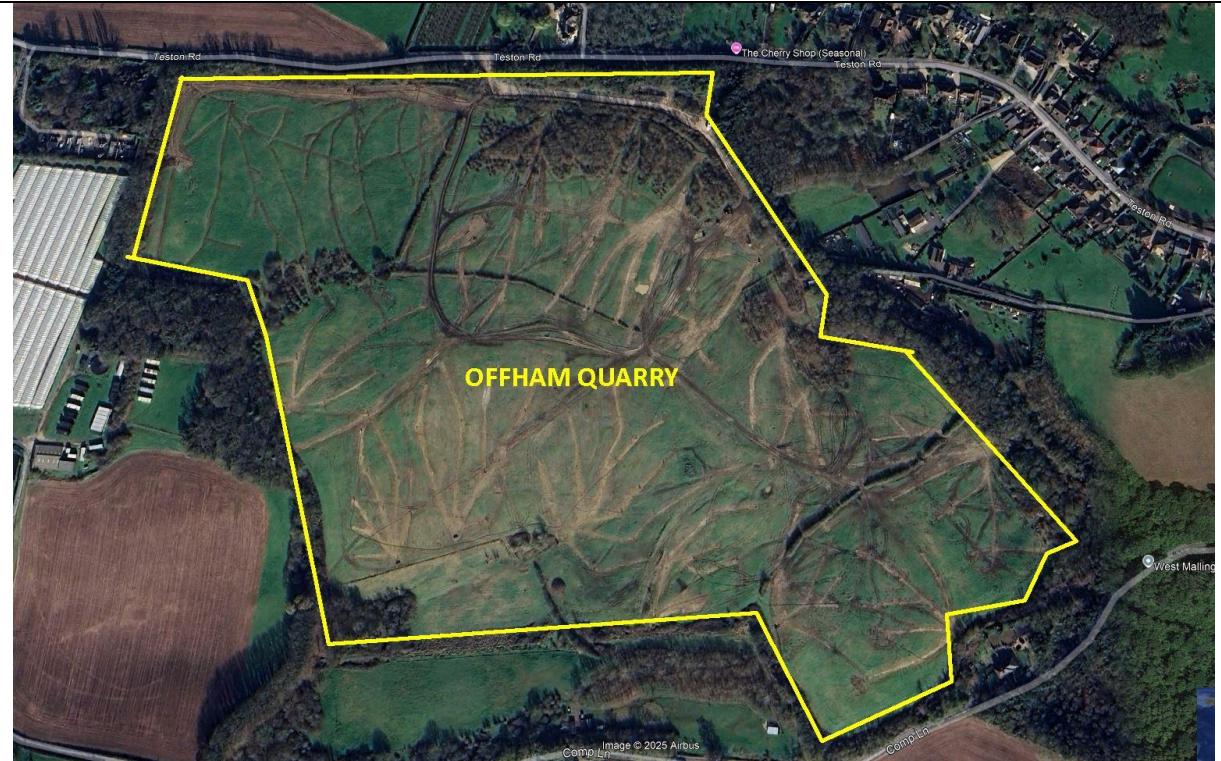
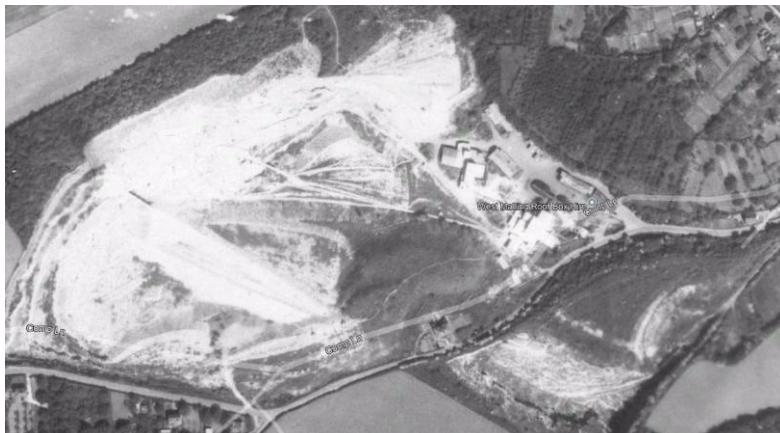
OFFHAM SOUTH 1940

ADDRESS	Teston Road Offham TQ652573
Geographical	BETWEEN Teston Road and Comp Road west of Offham
Operator/s	ARC/HANSON
Material Excavated	Ragstone, high quality, construction and sea-walling
Excavation Dates	
Landfill Dates	<i>About 2010</i>
Landfill Material	<i>Domestic Waste, local and from London</i>
Final Restoration Date	
Restored to	<i>Original landform</i>
Restored to	SOLAR FARM
Monitoring Regime	
COMMENTS	Later cells were engineered and lined and capped with plastic. Gas extracted. Carbon dioxide found in Aldon Lane area. Methane in cellar of house in Comp Lane

Since the original register was compiled, further reports backed up by this Google Historic image clearly show quarrying activity south of Comp Lane adjacent to the old southern entrance to the main quarry. Depth and fill unknown

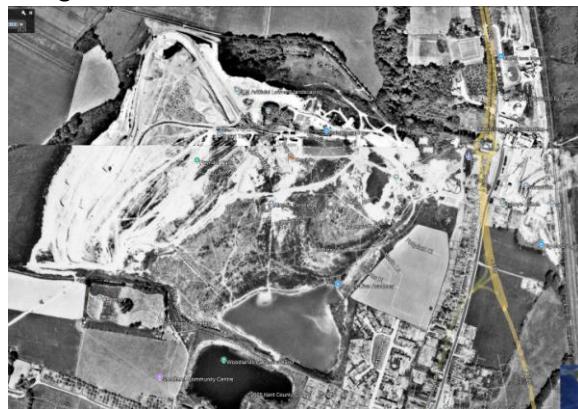
Google 1960

ADDRESS &	Ladds Lane & A228 Snodland
Geographical boundaries	West of A228. south of Ladds Lane, north of Paddlesworth Rd
Operator/s	Blue Circle Cement
Material Excavated	Chalk
Excavation Dates	Pre 1940s to 2000s
Landfill Dates	unknown
Landfill Material	unknown
Method	unknown
Final Restoration Date	unknown
Restored to	Original landform, and lakes
Restored to	Agricultural and housing
Monitoring Regime	unknown
COMMENTS

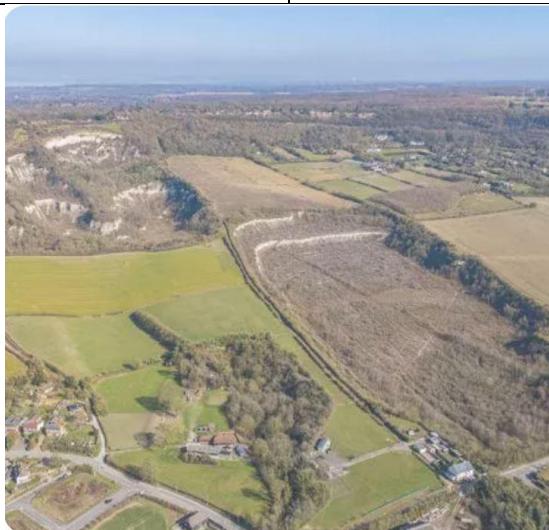
ADDRESS	East of South Burham
Geographical	
Operator/s	unknown
Material Excavated	unknown
Excavation Dates	unknown
Landfill Dates	Not landfilled - archaeological investigations
Restored to	<i>Left open</i>
Monitoring Regime	
COMMENTS	This site is far too important as a international/ national unique fossil area and must be preserved as such for its historical and geological benefit.

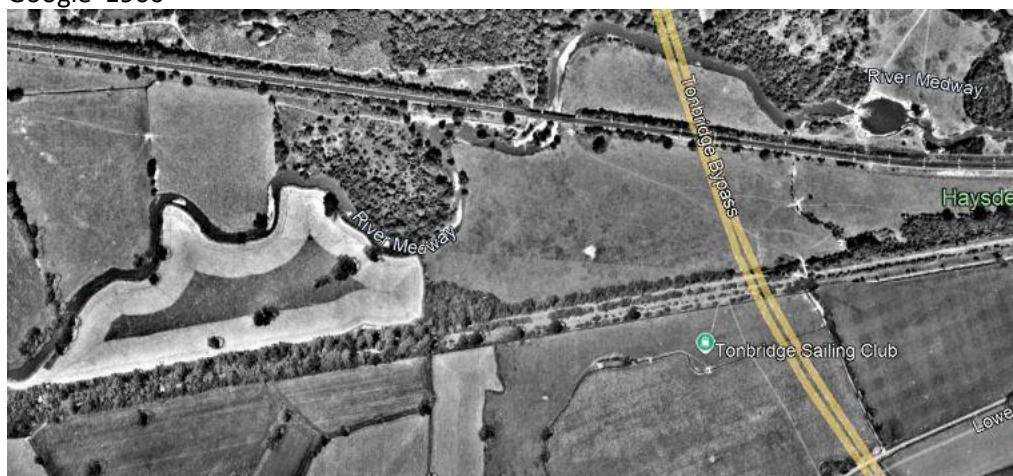
Google 1960

ADDRESS &	Lower Haysden Lane Tonbridge
Geographical boundaries	North of Lwr Haysden Lane, west of A21 Bypass, south of R Medway and Railway
Operator/s	Redland
Material Excavated	Sand & Gravel dredged
Excavation Dates	
Landfill Dates	
Landfill Material	Re-distributed overburden, flooded
Method	N/A
Final Restoration Date	1980s
Restored to	Lakes, public amenity
Monitoring Regime	N/A
COMMENTS

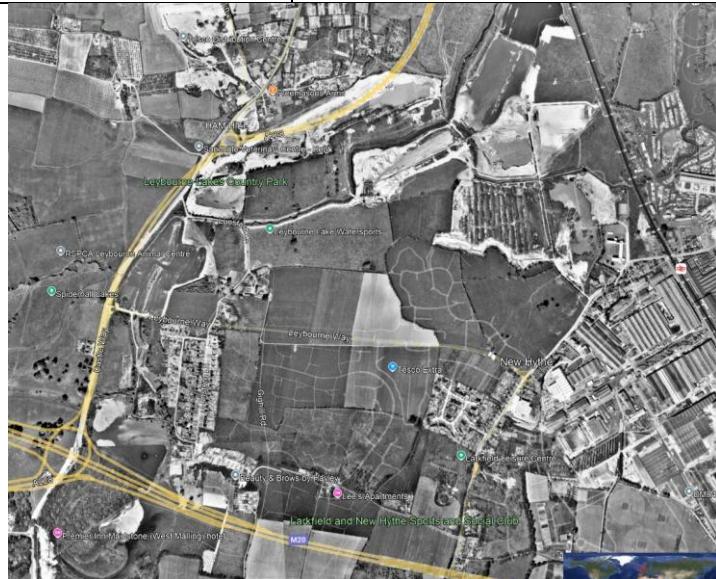
ADDRESS & Co-ordinates	Leybourne Lakes, east of A228, North & South of M20
Geographical boundaries	
Operator/s	Hall Aggregates, Redland Brick & Tile
Material Excavated	<i>Sand</i>
Excavation Dates	<i>1950/60s</i>
Landfill Dates	<i>Flooded for amenity use</i>
Landfill Material	<i>Some Inert waste</i>
Method	<i>Engineered Fill,</i>
Final Restoration Date	
Restored to	<i>Original landform with lakes</i>
Restored to	
Monitoring Regime	<i>Unknown</i>
COMMENTS

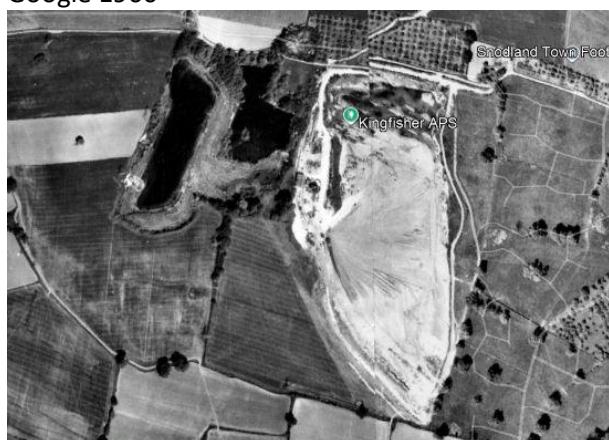
Google 1960

ADDRESS & Co-ordinates	Paddlesworth Rd Snodland
Geographical boundaries	South of Paddlesworth Rd
Operator/s	Blue Circle Cement
Material Excavated	Clay for Blue Circle Holborough Works. Cableway delivery
Excavation Dates	1940s- 1980s?
Landfill Dates	Flooded
Landfill Material	Redistribution of overburden, flooded
Method	N/A
Final Restoration Date	N/A
Restored to	Lakes
Monitoring Regime	
COMMENTS

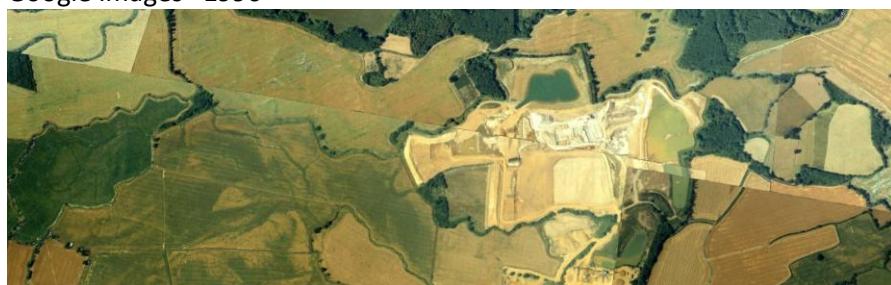
Google Images 1990

ADDRESS	Stonecastle Farm Quarry Hartlake Road Golden Green Tonbridge Kent
Geographical boundaries	South of River Medway, North of Whetsted Rd A228 Site outlines estimated. Early in TWBC, later in Bourne Ward TMBC
Operator/s	Unknown
Material Excavated	Sand & Ballast
Excavation Dates	1990 - 2007
Landfill Dates	Not backfilled, allowed to flood
Landfill Material	N/A Overburden was moved and redistributed on site, no import
Method	N/A
Final Restoration Date	2020s
Restored to	Lakes
Restored to	Lakes
Monitoring Regime	Unknown
COMMENTS

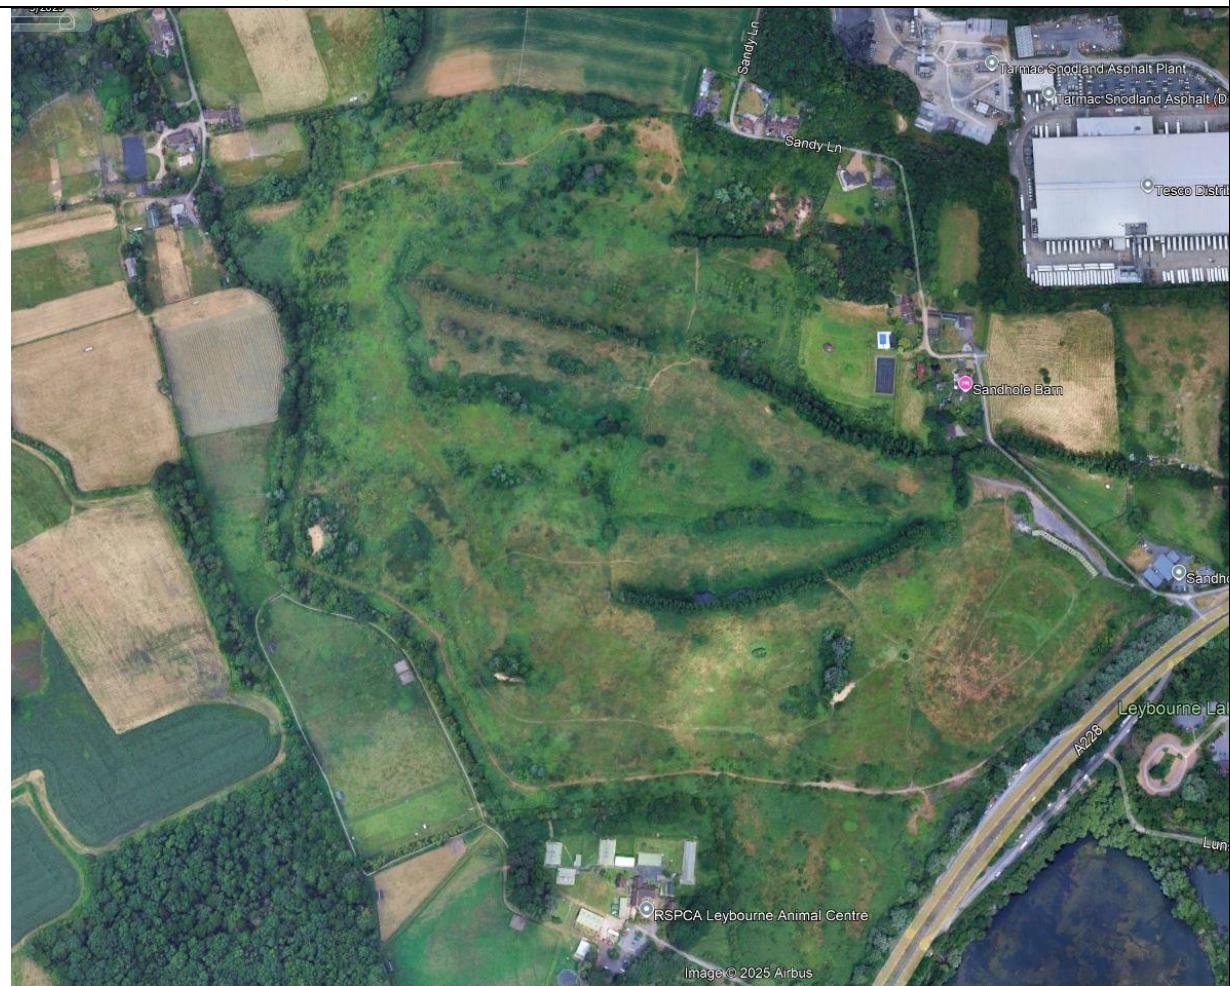
ADDRESS & Co-ordinates	North of Malling Rd, Tesco Depot and Ham Hill Sandpit
Geographical boundaries	<i>North South East or West, Road names, rivers, features forming boundary</i>
Operator/s	
Material Excavated	<i>sand,</i>
Excavation Dates	
Landfill Dates	
Landfill Material	<i>General waste. Industrial waste, Domestic Waste, Inert waste, overburden</i>
Method	<i>Edge tip, Engineered Fill, cell and cap</i>
Final Restoration Date	
Restored to	<i>Original landform, local level, lower level</i>
Restored to	<i>Agricultural, woodland, commercial, housing</i>
Monitoring Regime	<i>Gas or watercourse, subsidence</i>
COMMENTS

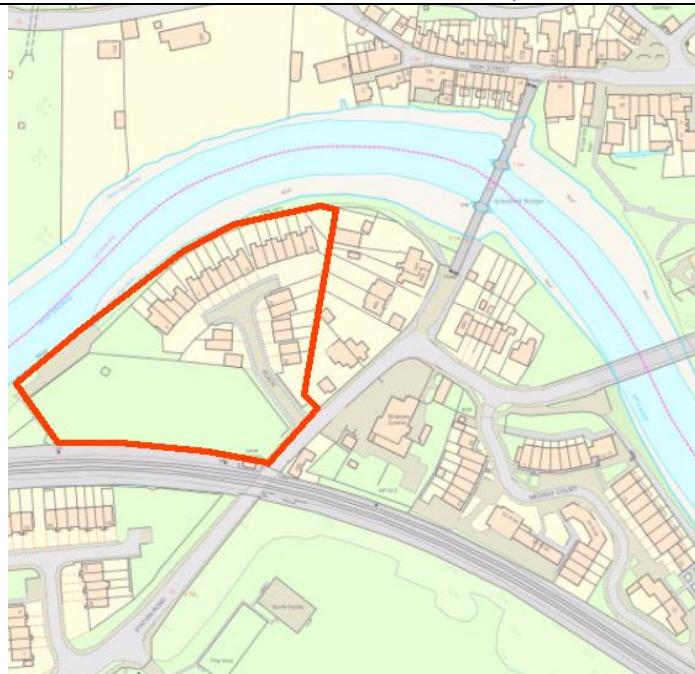
ADDRESS& Co-ordinates	Oast Park Golf Club, Malling Road Snodland TQ693604
Geographical boundaries	Malling Road to east, Snodland Road to north RSPCA centre to south, Bridleway to west
Operator/s	
Material Excavated	Unknown
Excavation Dates	
Landfill Dates	1990's
Landfill Material	<i>Mixed waste soils from various sources</i>
Method	
Final Restoration Date	
Restored to	<i>Higher level, undulating to make a golf course</i>
Restored to	
Monitoring Regime	
COMMENTS

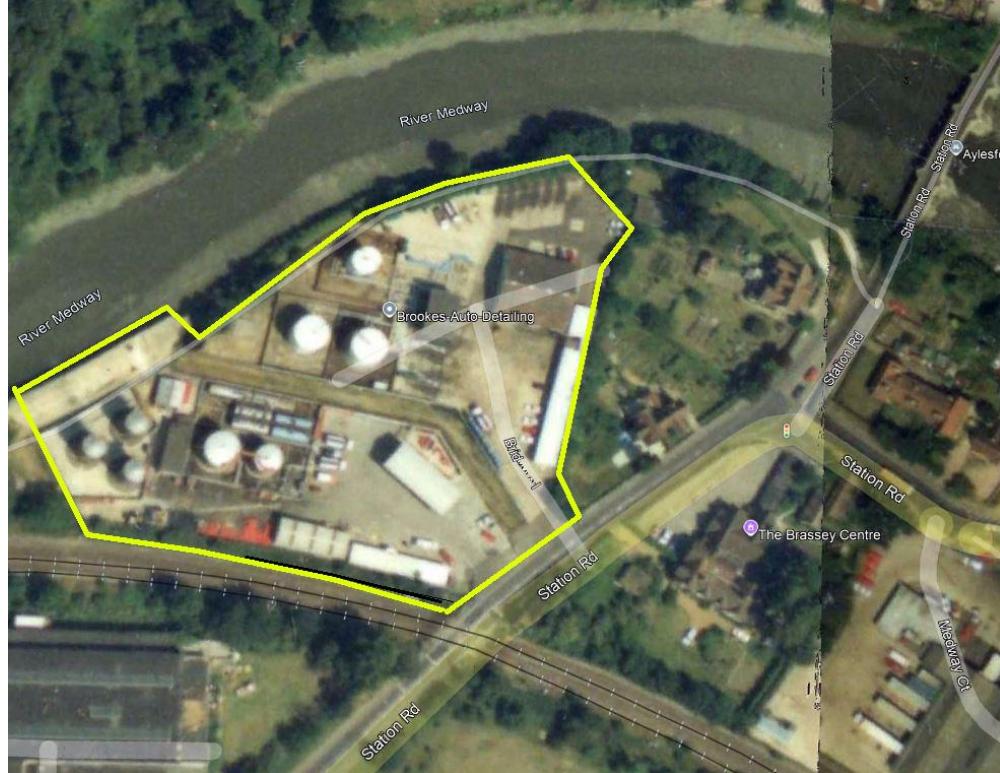
ADDRESS	Station Rd Aylesford
Geographical	North of Railway
Operator/s	Shell?
Restored to	<i>Original landform,</i>
Restored to	<i>Part open, part housing</i>
Monitoring Regime	<i>Unknown</i>
COMMENTS

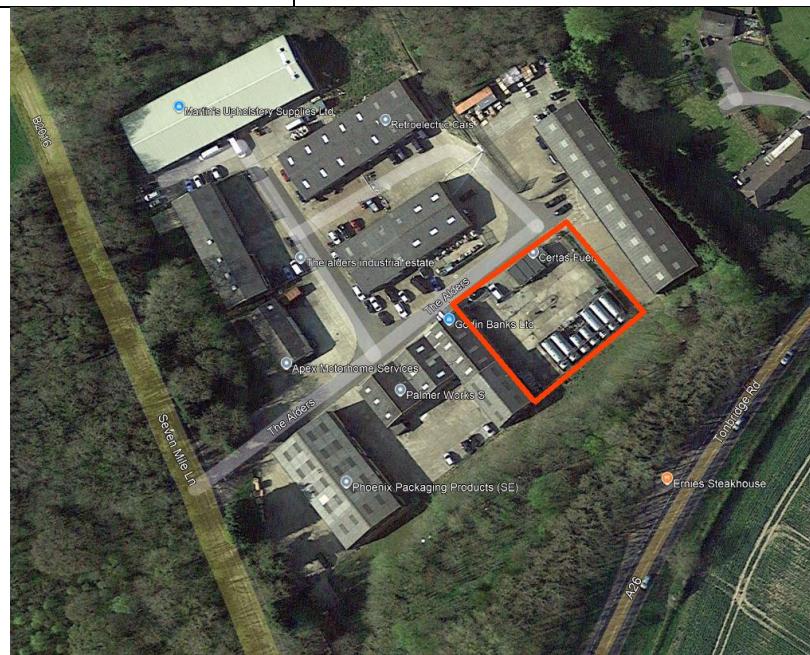
ADDRESS	Allders Estate, Seven Mile Lane, Mereworth
Geographical boundaries	East of 7 Mile Lane, north west of A26
Operator/s	Total, Certas, ?
Restored to	<i>Still operational</i>
Restored to	<i>commercial,</i>
Monitoring Regime	<i>n/a</i>
COMMENTS
